Appendix E – Footpaths & Drainage

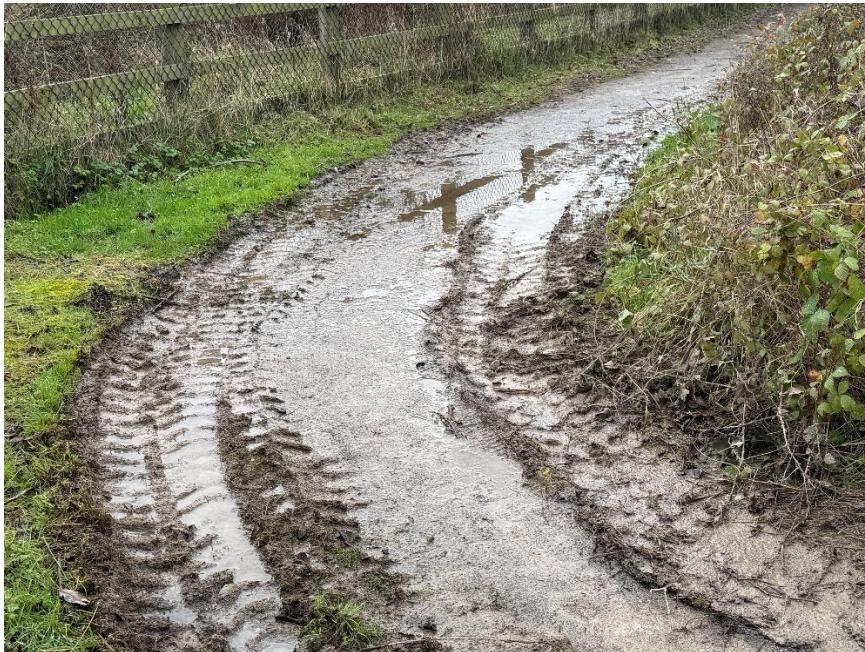
Poor drainage to foot path in south west corner of the site. Water flows from higher ground to the left across the footpath. An existing drainage inlet is in the land to the right.

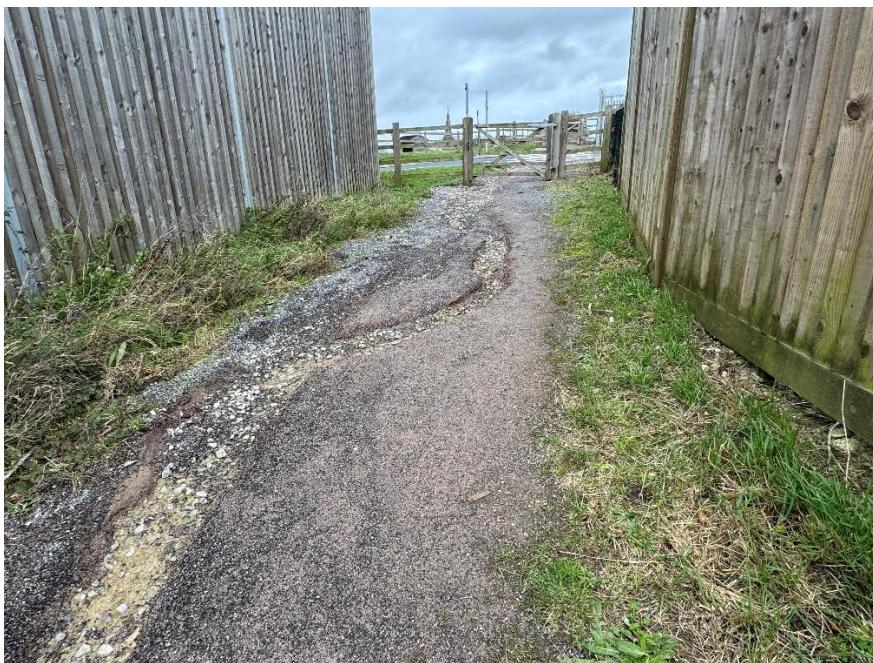
Poor drainage to the staff car park entrance road results in surface water from the road running down the foot path causing damage as shown. This has previously been repaired.

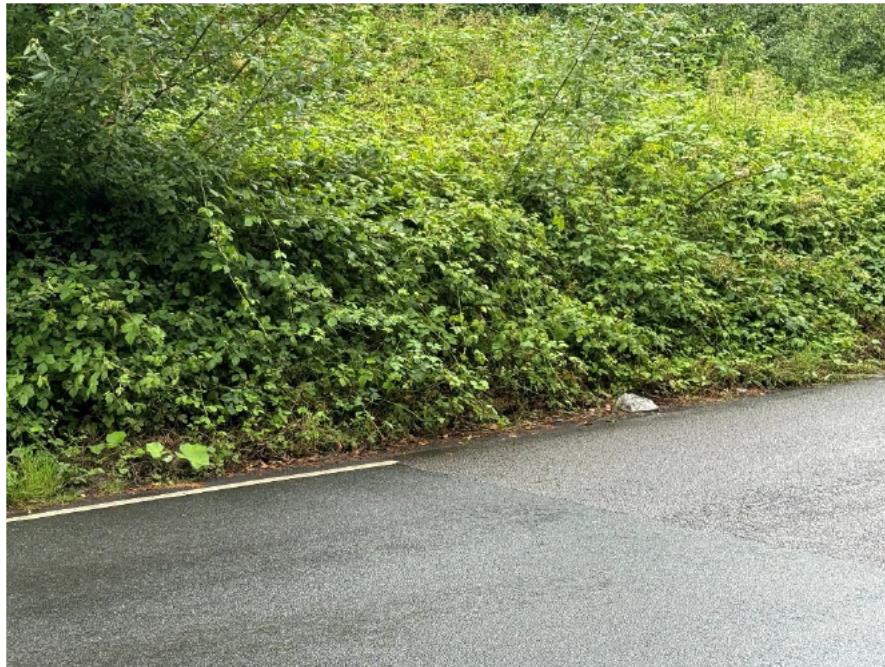
Drainage for the site and for Church Road is within this verge to the site which is no-longer being maintained. 3 gulleys are located in view of this image, all covered.

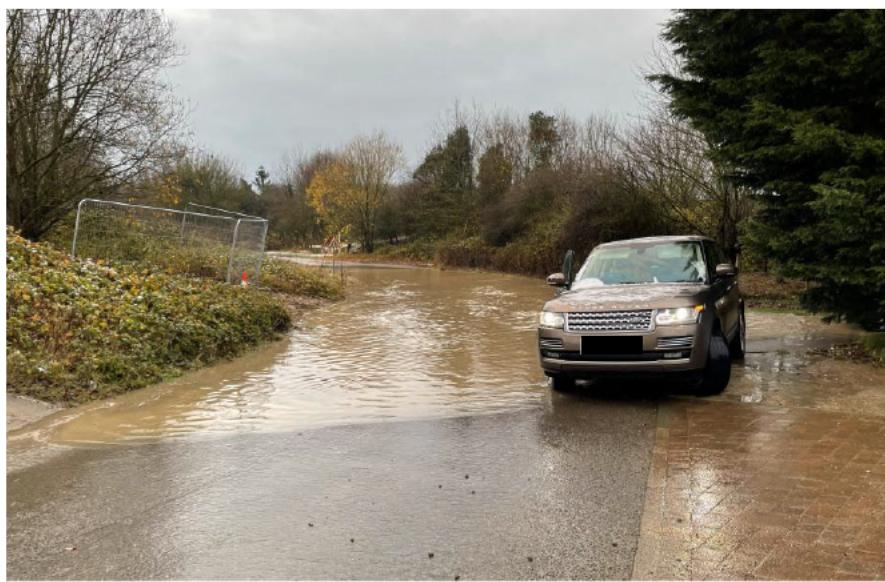
Example of frequent flooding on Church Road during construction due to poor maintenance of existing drainage.

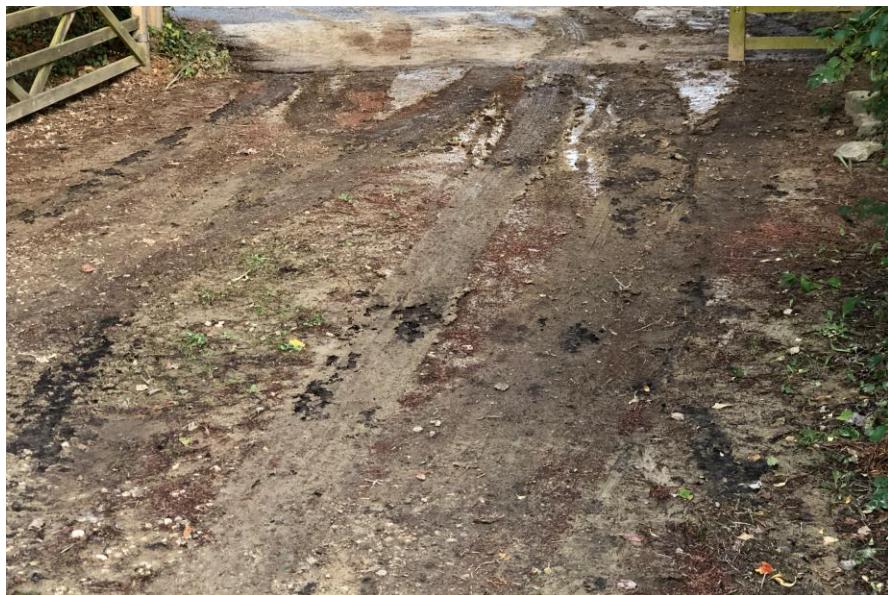
Resulting damage to driveway from clay & silt deposits due to flooding.
