**Appendix 13 - Lighting Technical Note**

**Sevington Inland Border Facility,  
Mersham, Ashford TN25 6GE  
Application Reference No: CROWN/2025/0000002**

Lighting Technical Note

## Lighting Survey Report

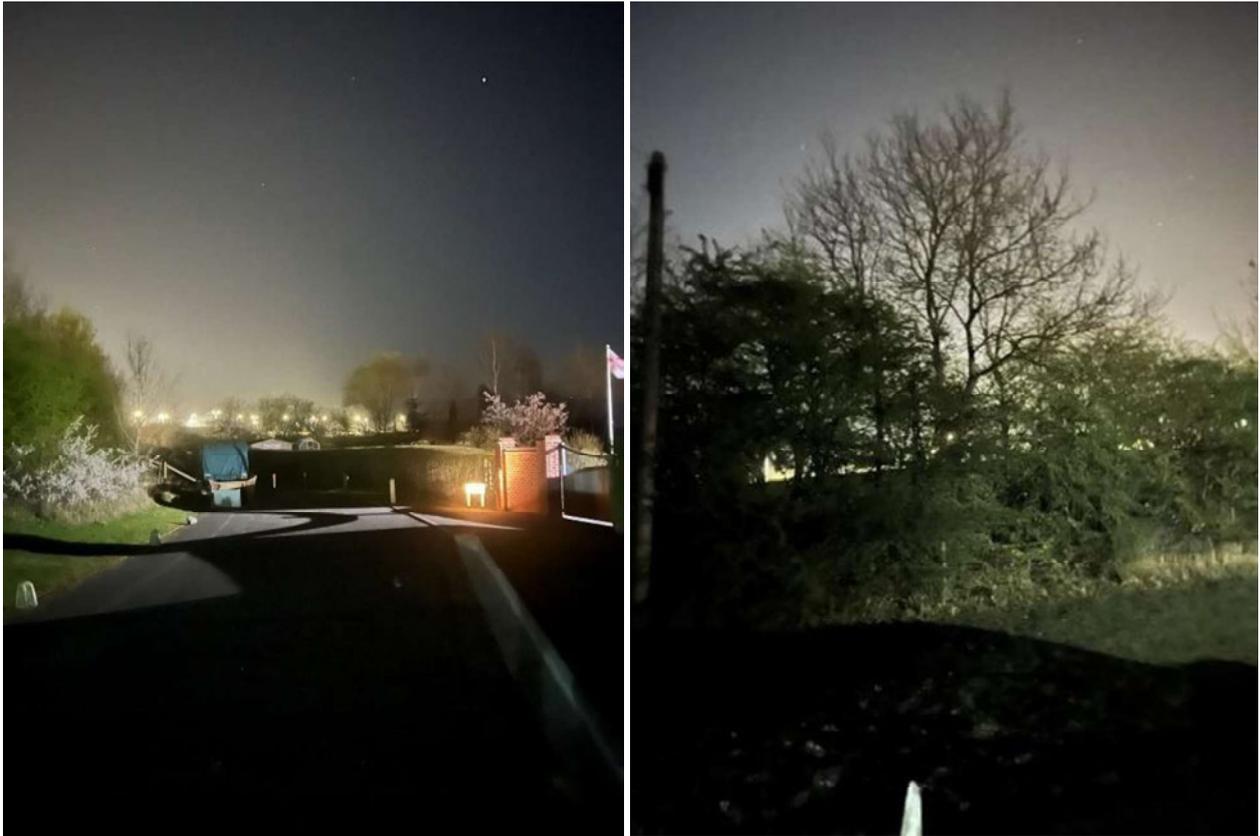
Figure 2: Pictures taken from 2nd of April

#### 3.1 Boundary Area 1

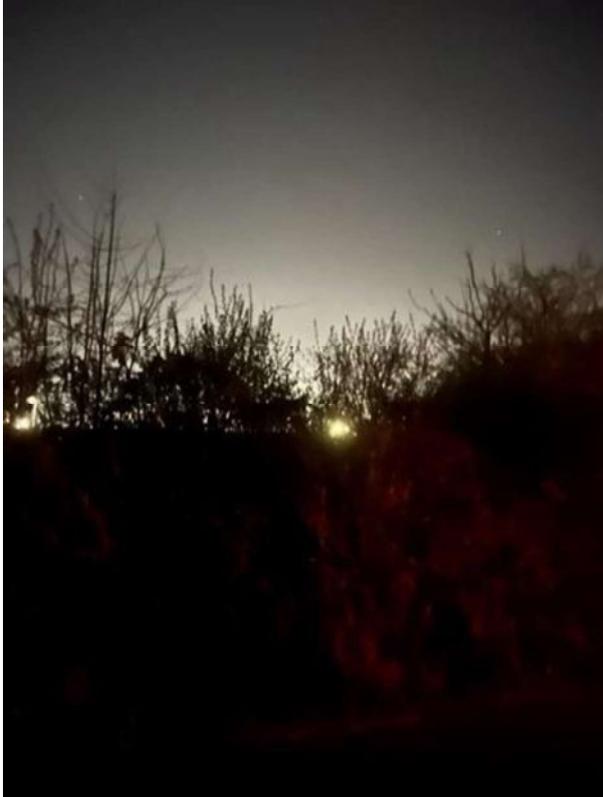
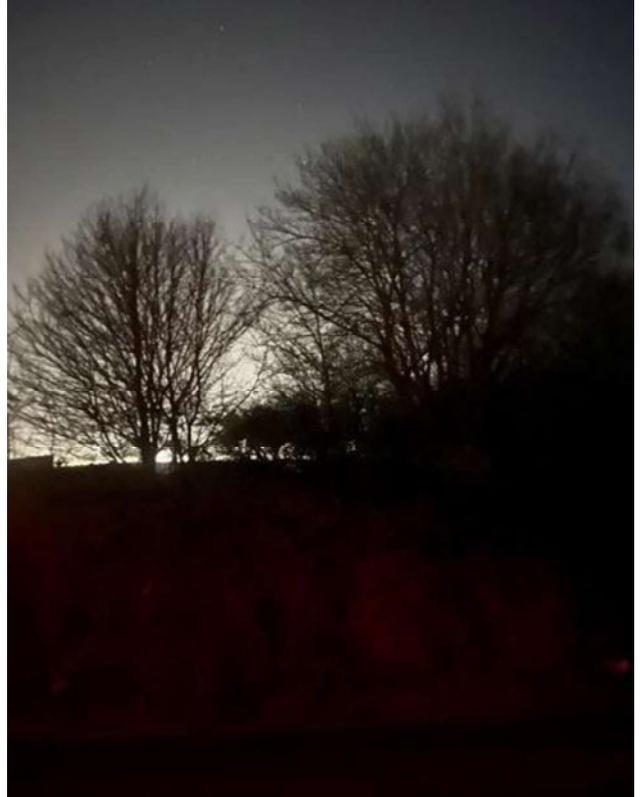
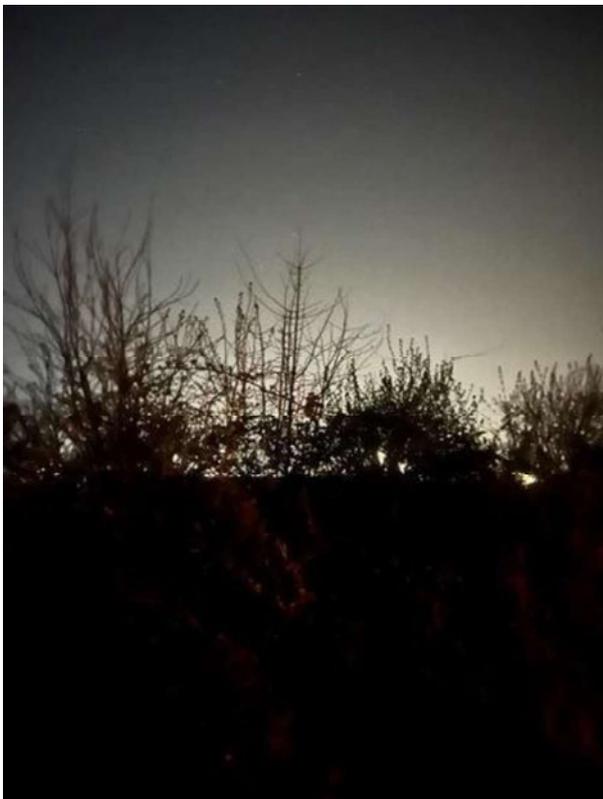
Figure 4: Pictures taken from 2nd of April

### 3.2 Boundary Area 2

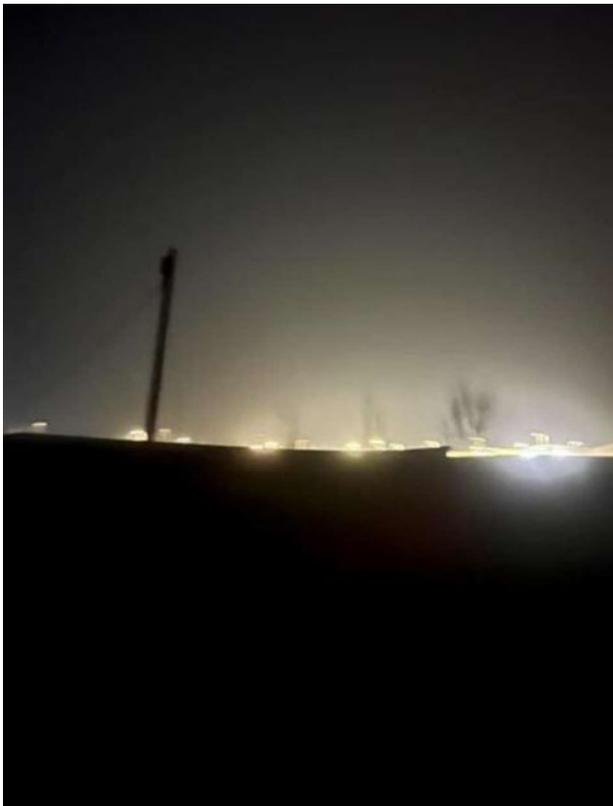
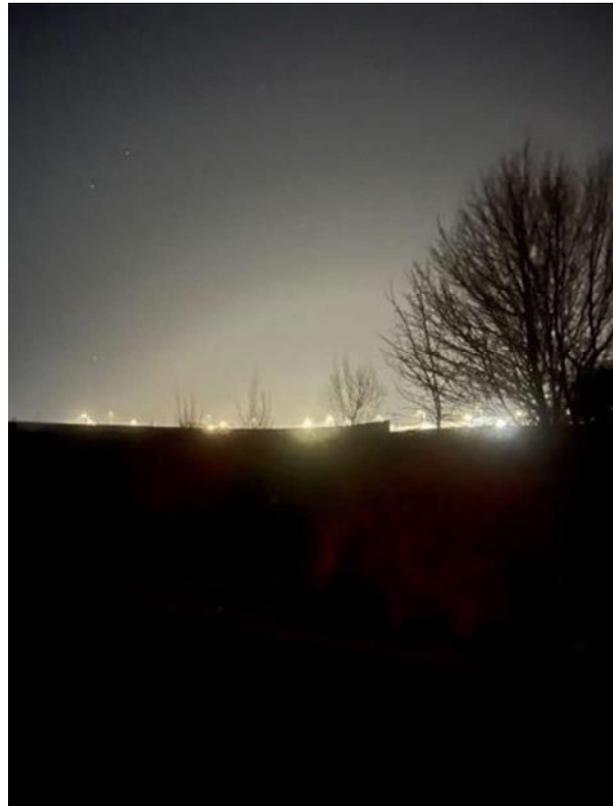
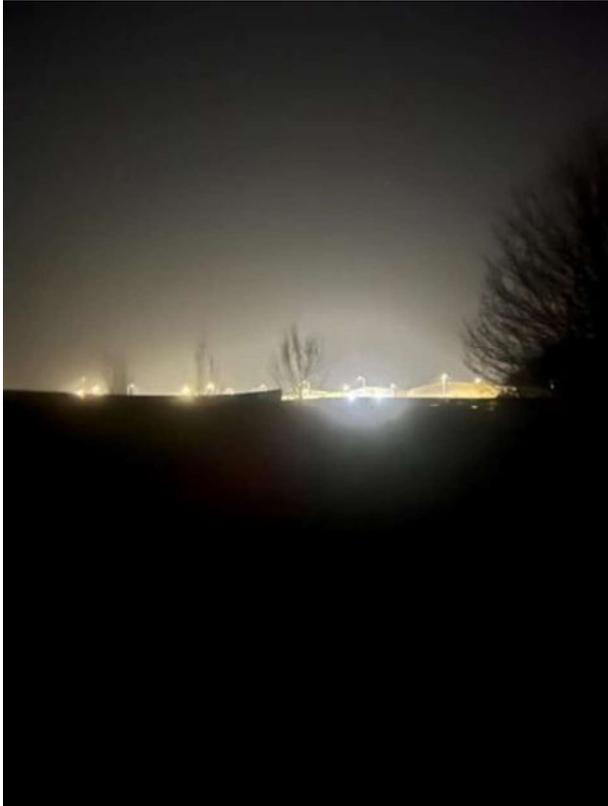
Figure 6: Pictures taken from 2nd of April

### 3.3 Boundary Area 3

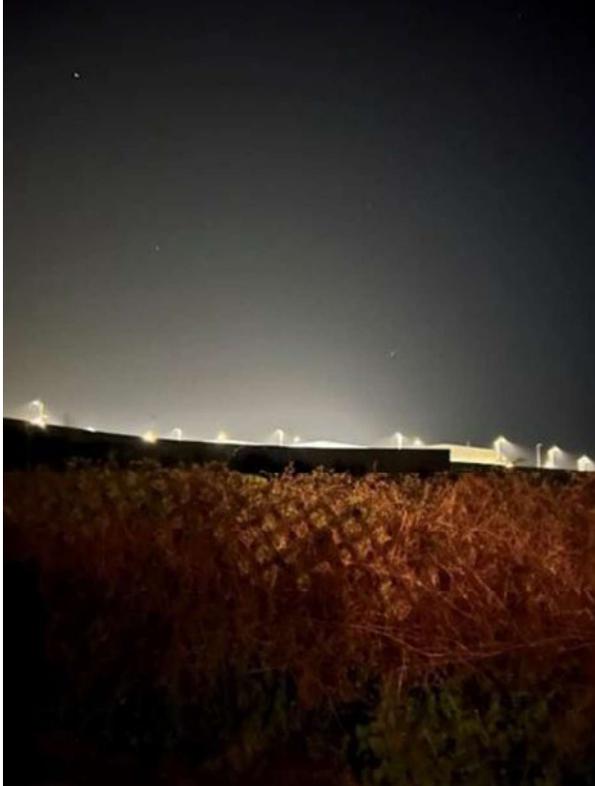
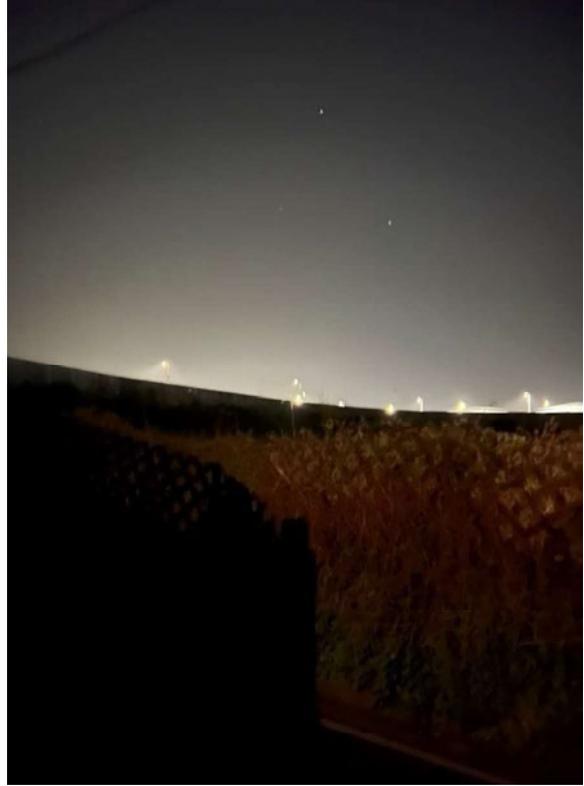
Figure 8: Pictures taken from 2nd of April

### 3.4 Boundary Area 4

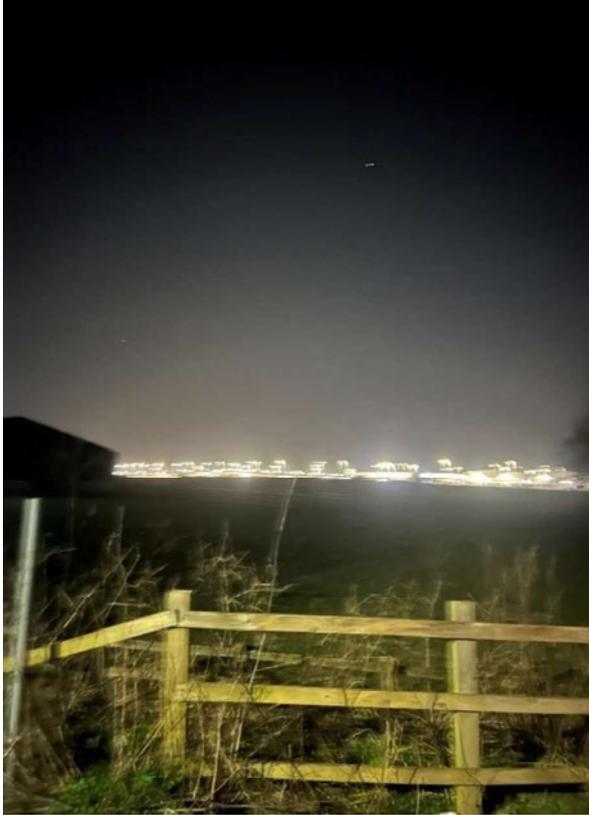
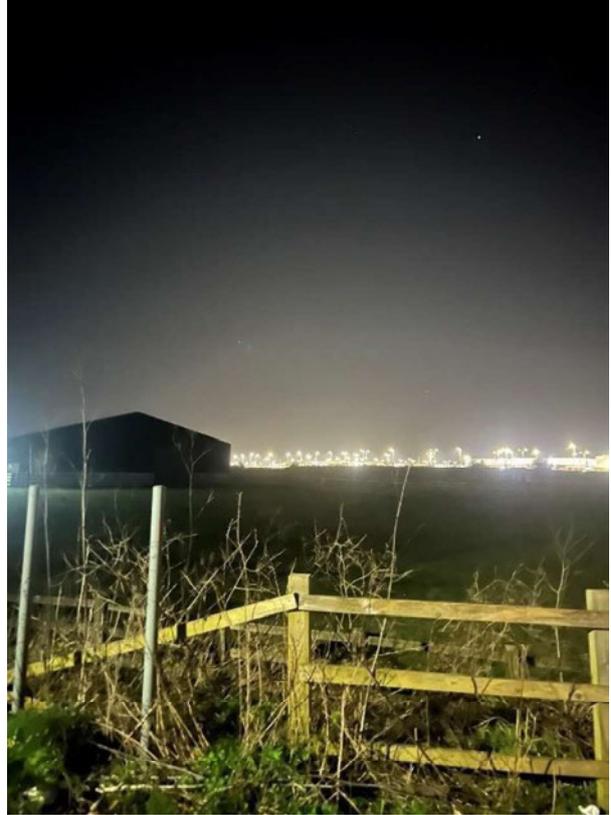
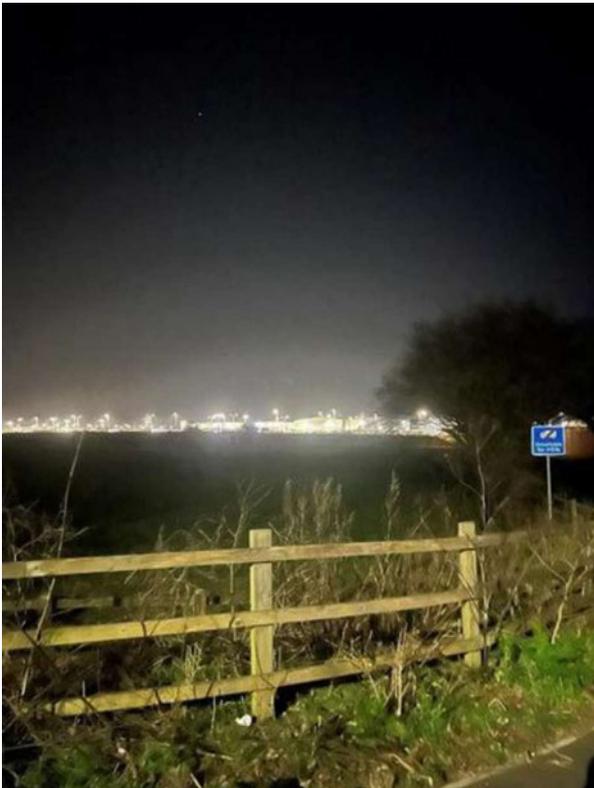
Figure 10: Pictures taken from 2nd of April

### 3.5 Boundary Area 5

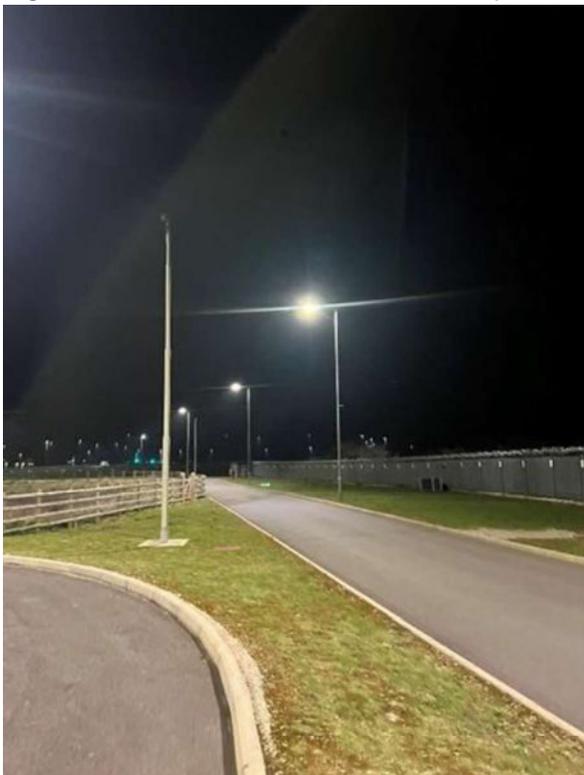
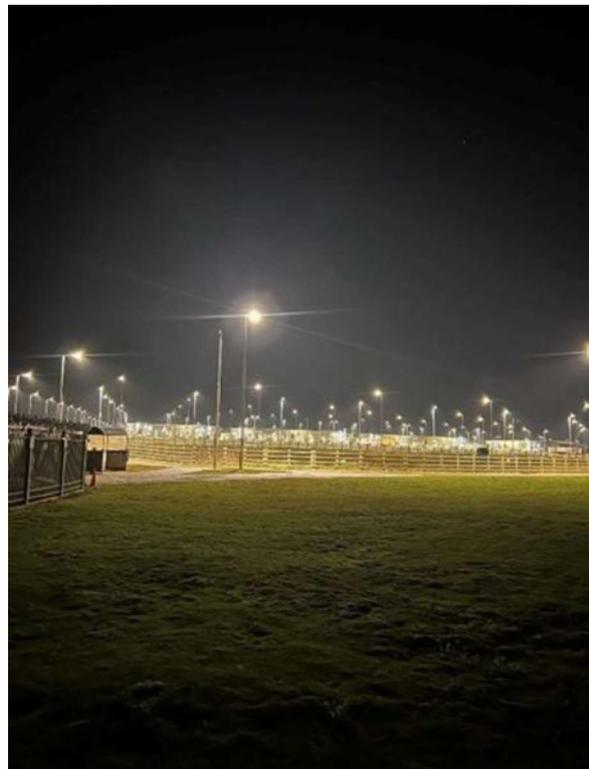
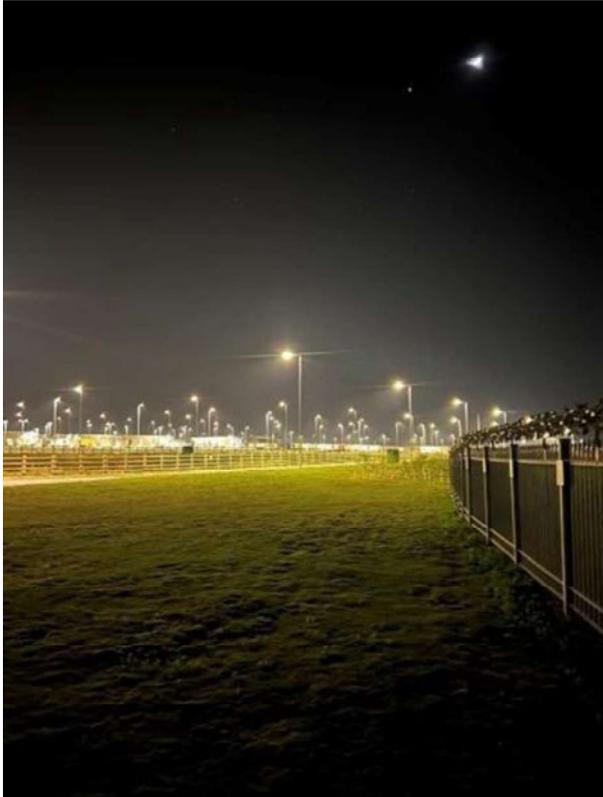
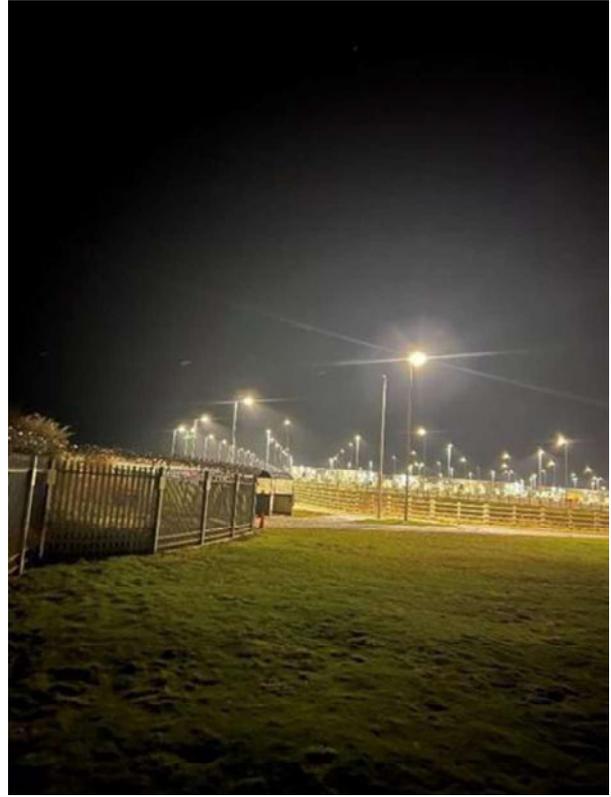
Figure 12: Pictures taken from 2nd of April

### 3.6 Boundary Area 6

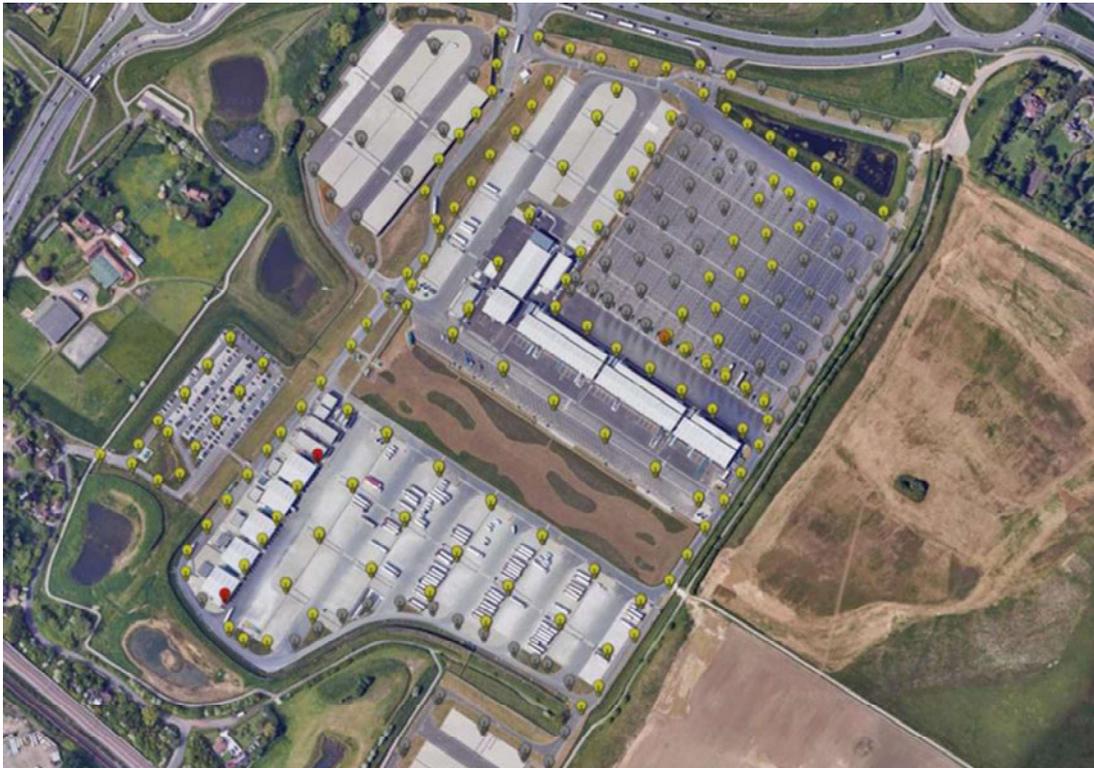
Image below indicating luminaires that were on/off during the site visit on 6th October and identifies a significant reduction compared to the previous visit, as can also be seen from the above images. This includes switching off lighting in areas including Romeo, Tango and large areas of the swim lanes and dimming of lighting levels across the development.

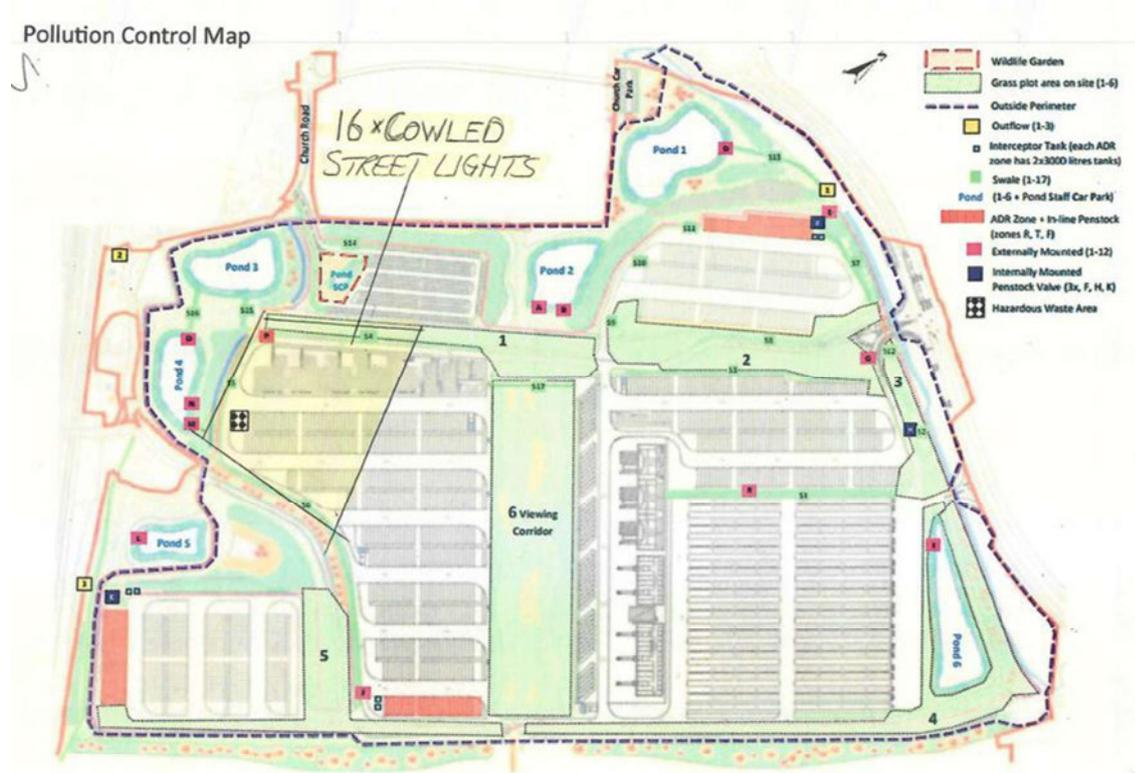
Figure 14: Pollution Control Map

Image below identifying where baffles installed since the original installation (16 luminaires).
