Appendix A – Aesthetics - Photo's & commentary

General Aesthetics

Sevington & Church Road

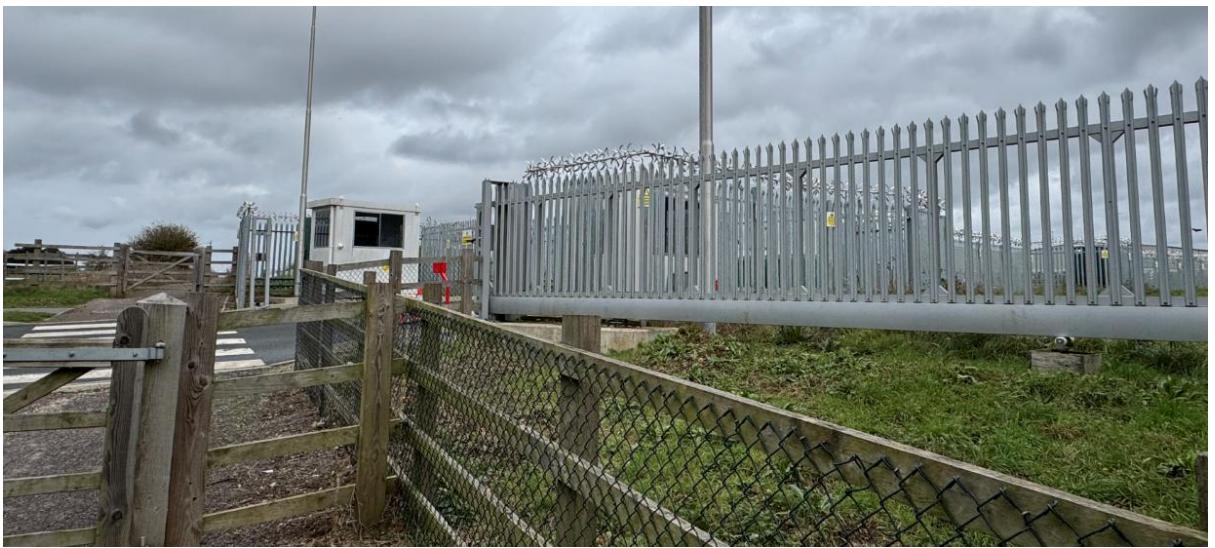
View of staff entrance from the footpath approaching from the south.

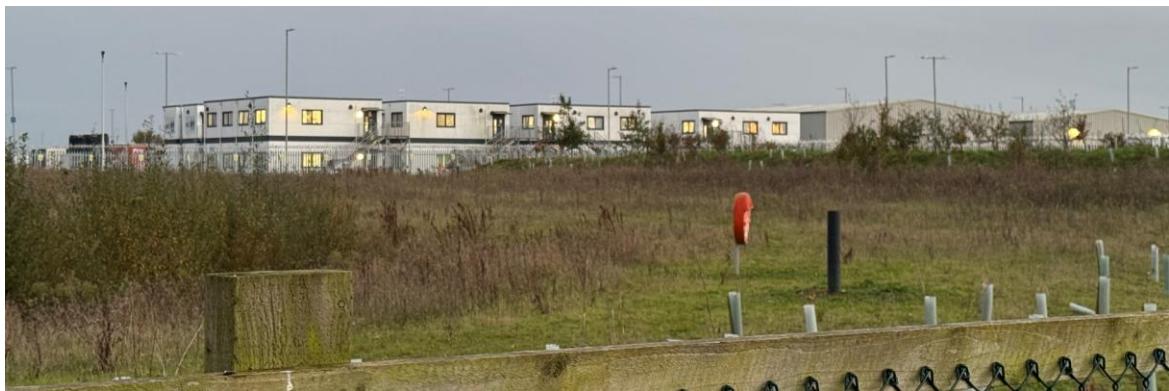
View of prefabricated buildings from the public footpath near to St Mary's Church.

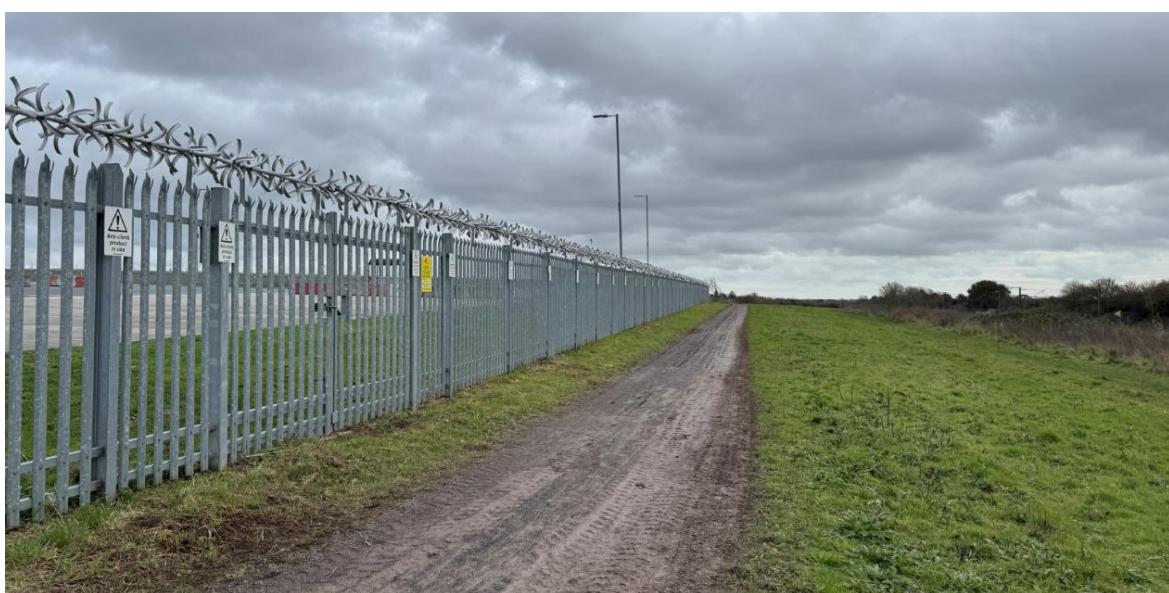
Boundary treatment facing countryside – southern part of the site.

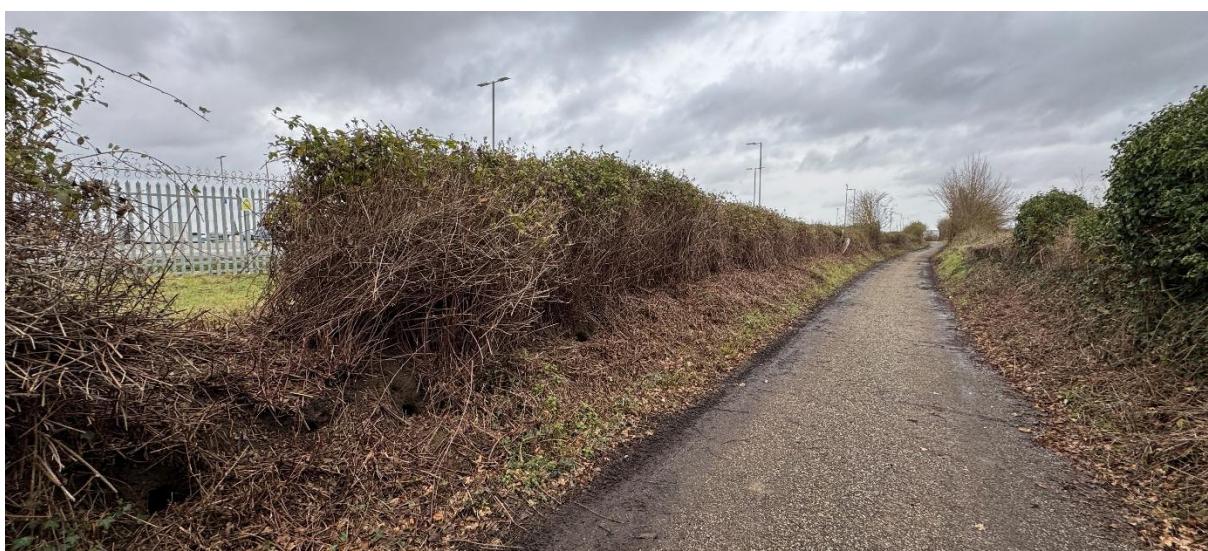
Example of how a buffer zone and existing hedging provide screening.

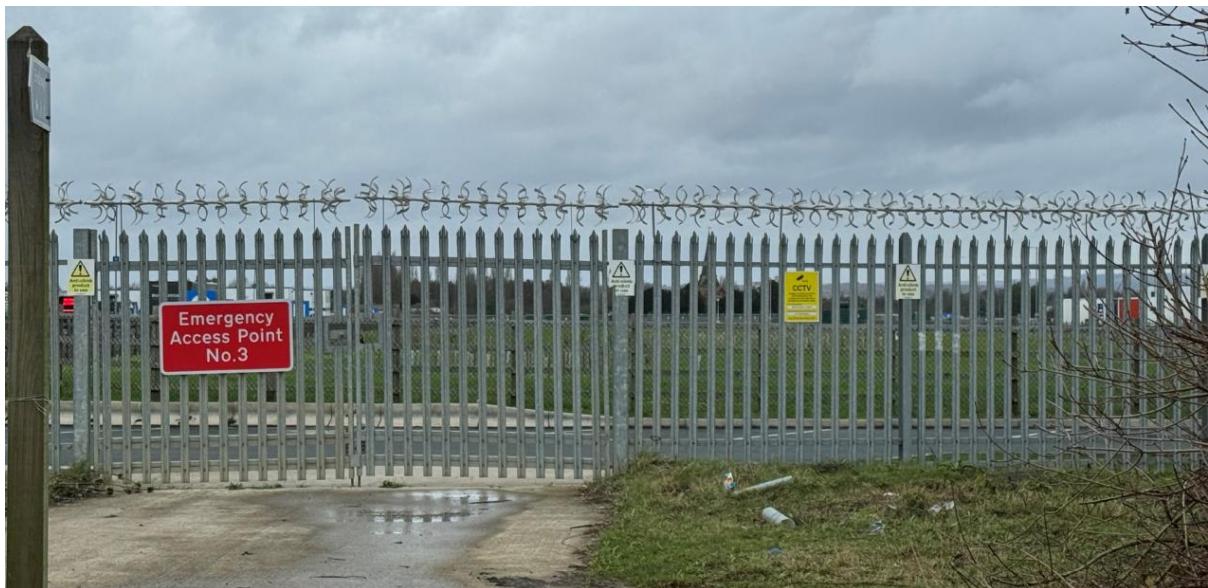
View towards St Marys Church from AE639 through the land to the east. St Marys can be seen to the left of the CCTV sign.

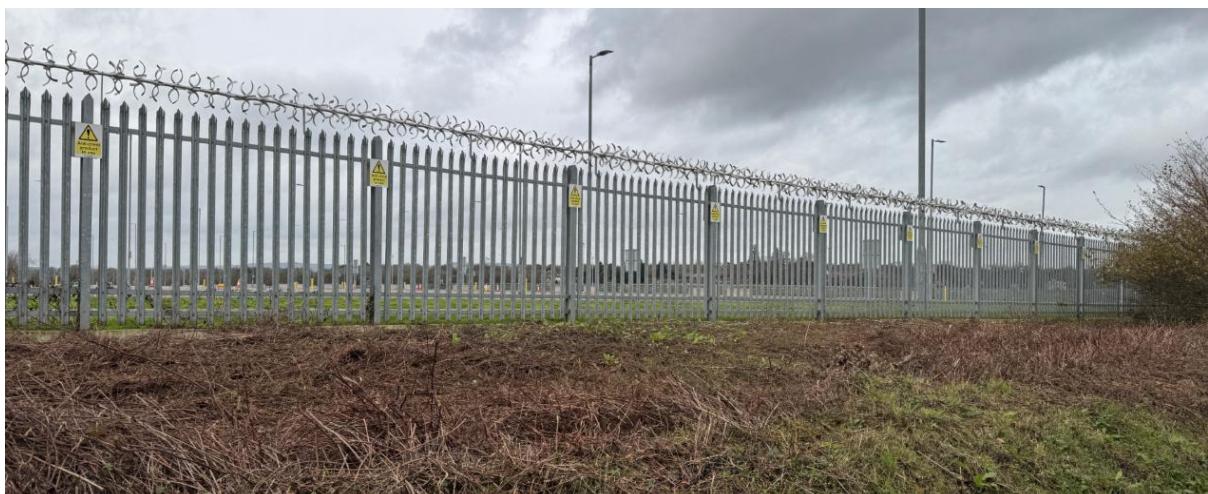
Areas where hedgerows appear to have been removed exposing the galvanised palisade fencing to the east of the site.

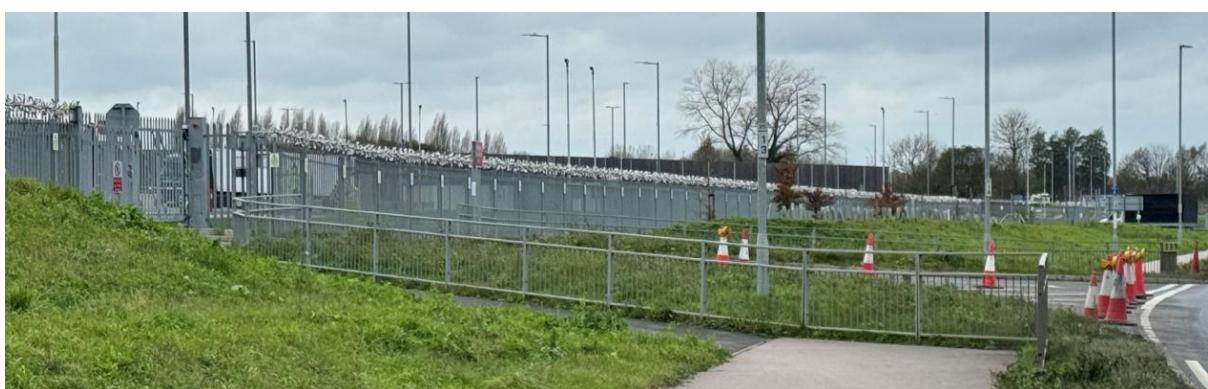
View towards St Mary's Church from the A2070 J10A link road to the north.

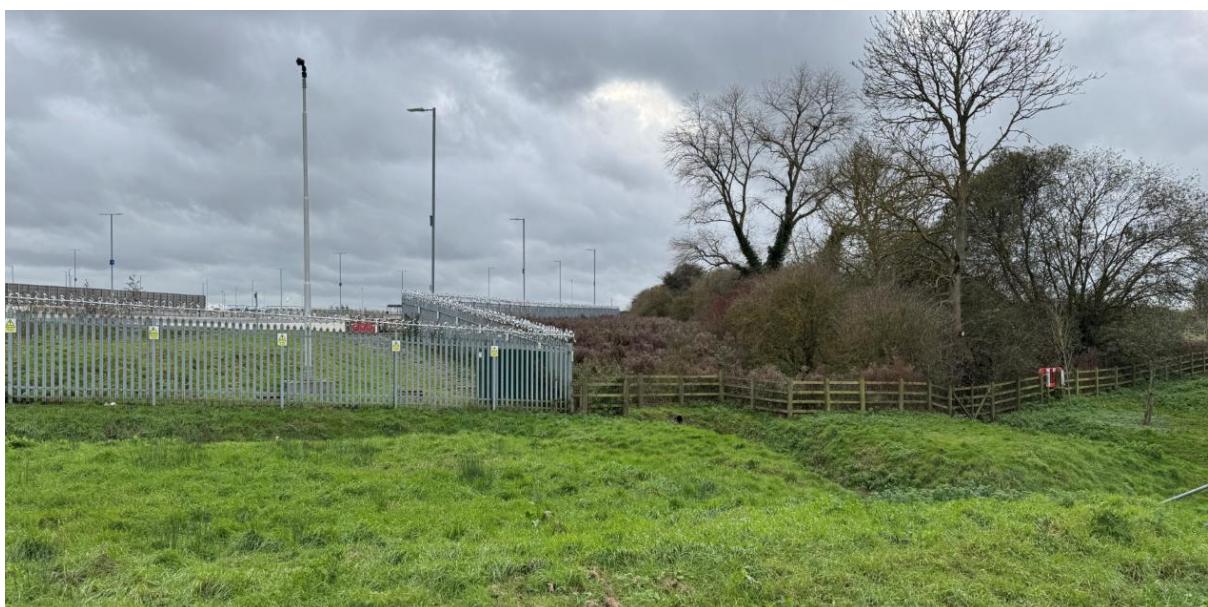
Existing ditch leading to Old Mill Stream near St Marys Church with adjacent site aesthetic.

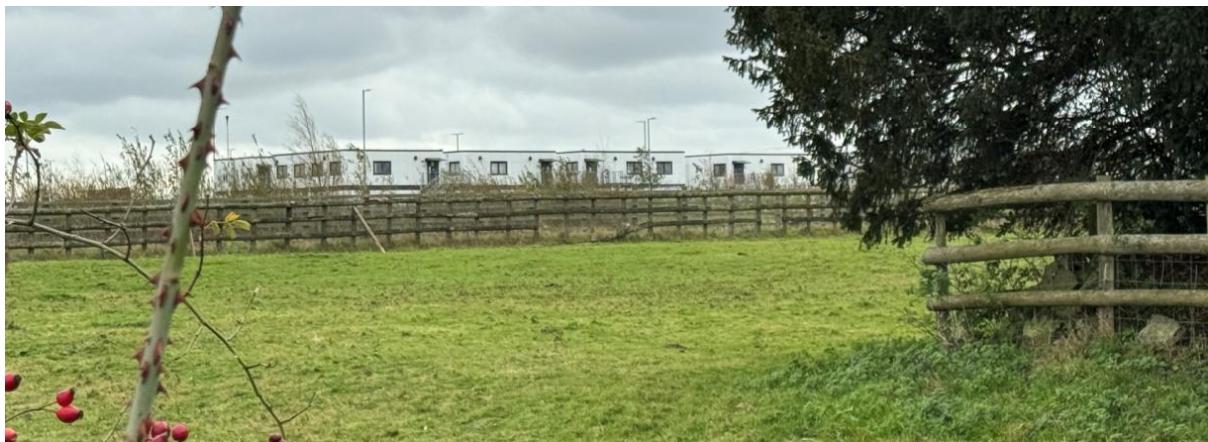
View of the site adjacent to St Marys Church.

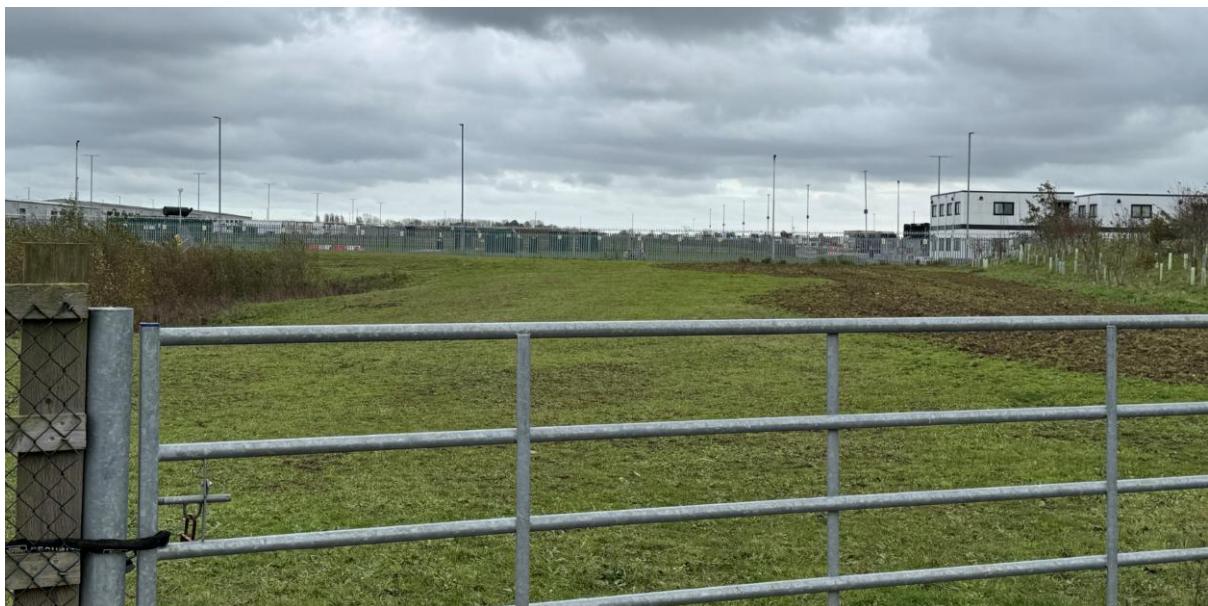
Views of buildings from the footpath across unplanted landscape in the position of the original route of AE639.
