Campsfield IRC Expansion

Detailed Unexploded Ordnance (UXO) Threat and Risk Assessment with Risk Mitigation Strategy

6 Alpha Associates Ltd

Project No.: 10029

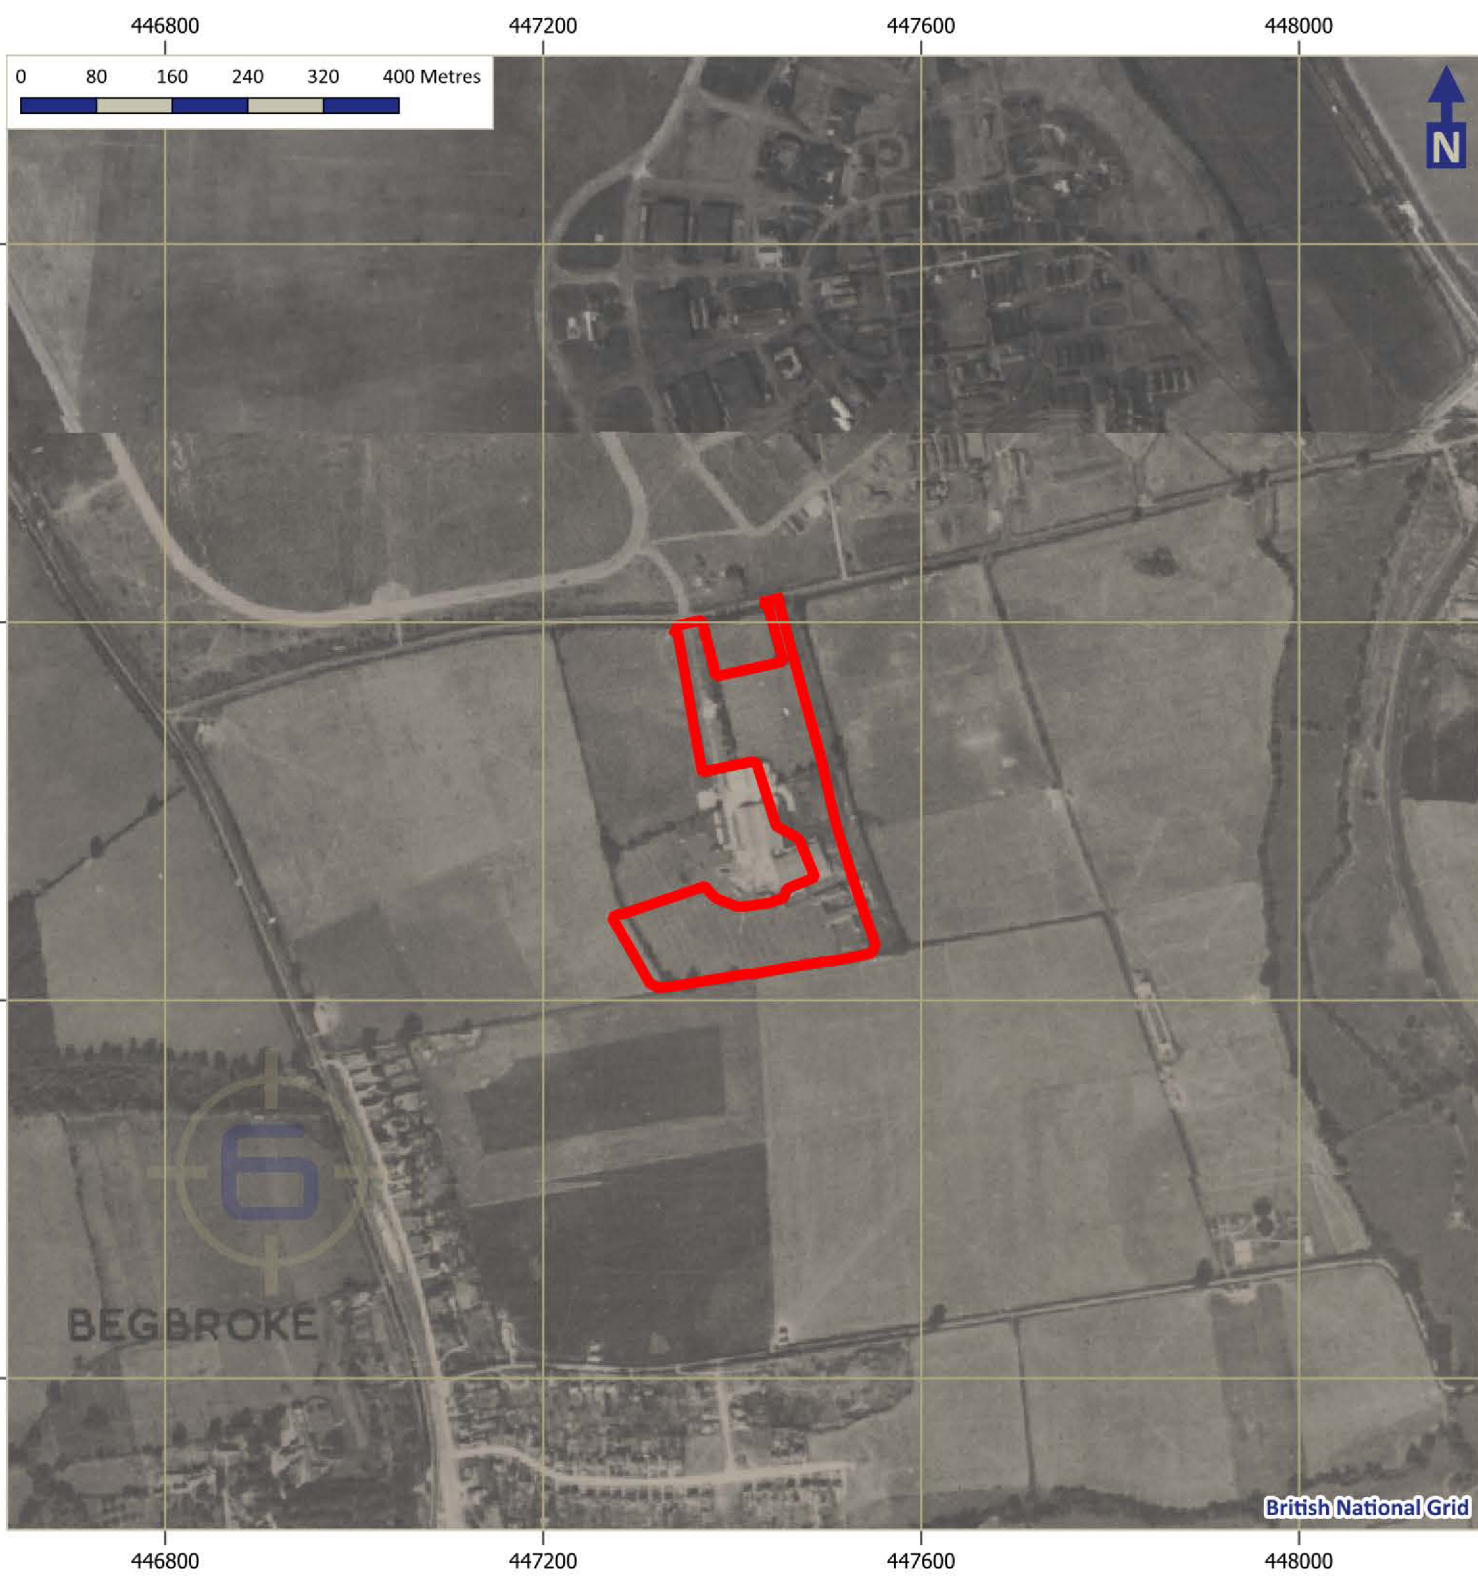
Appendix 4 – 1945 Aerial Photography

1945 Aerial Photography

The CS mapping prior to WWII (1936) and aerial photography (1945) shows that the Study Site was located within a densely developed urban area during WWII, with the Study Site itself consisting of *Campsfield House* and undeveloped ground. Given the undermentioned use of *Campsfield House* as a servicing and repair facility during WWII, it is likely that the Study Site would have been accessed frequently during WWII and would have been with inspected for UXB entry holes following any air raids, which would have been noted and dealt with at the time. Given that sections of the Study Site were undeveloped, however, and it is unknown how comprehensive these inspections would have been. Moreover, as bomb damage was recorded on-site, it is possible that bomb damage debris may have concealed a UXB entry hole causing it to have gone unnoticed.

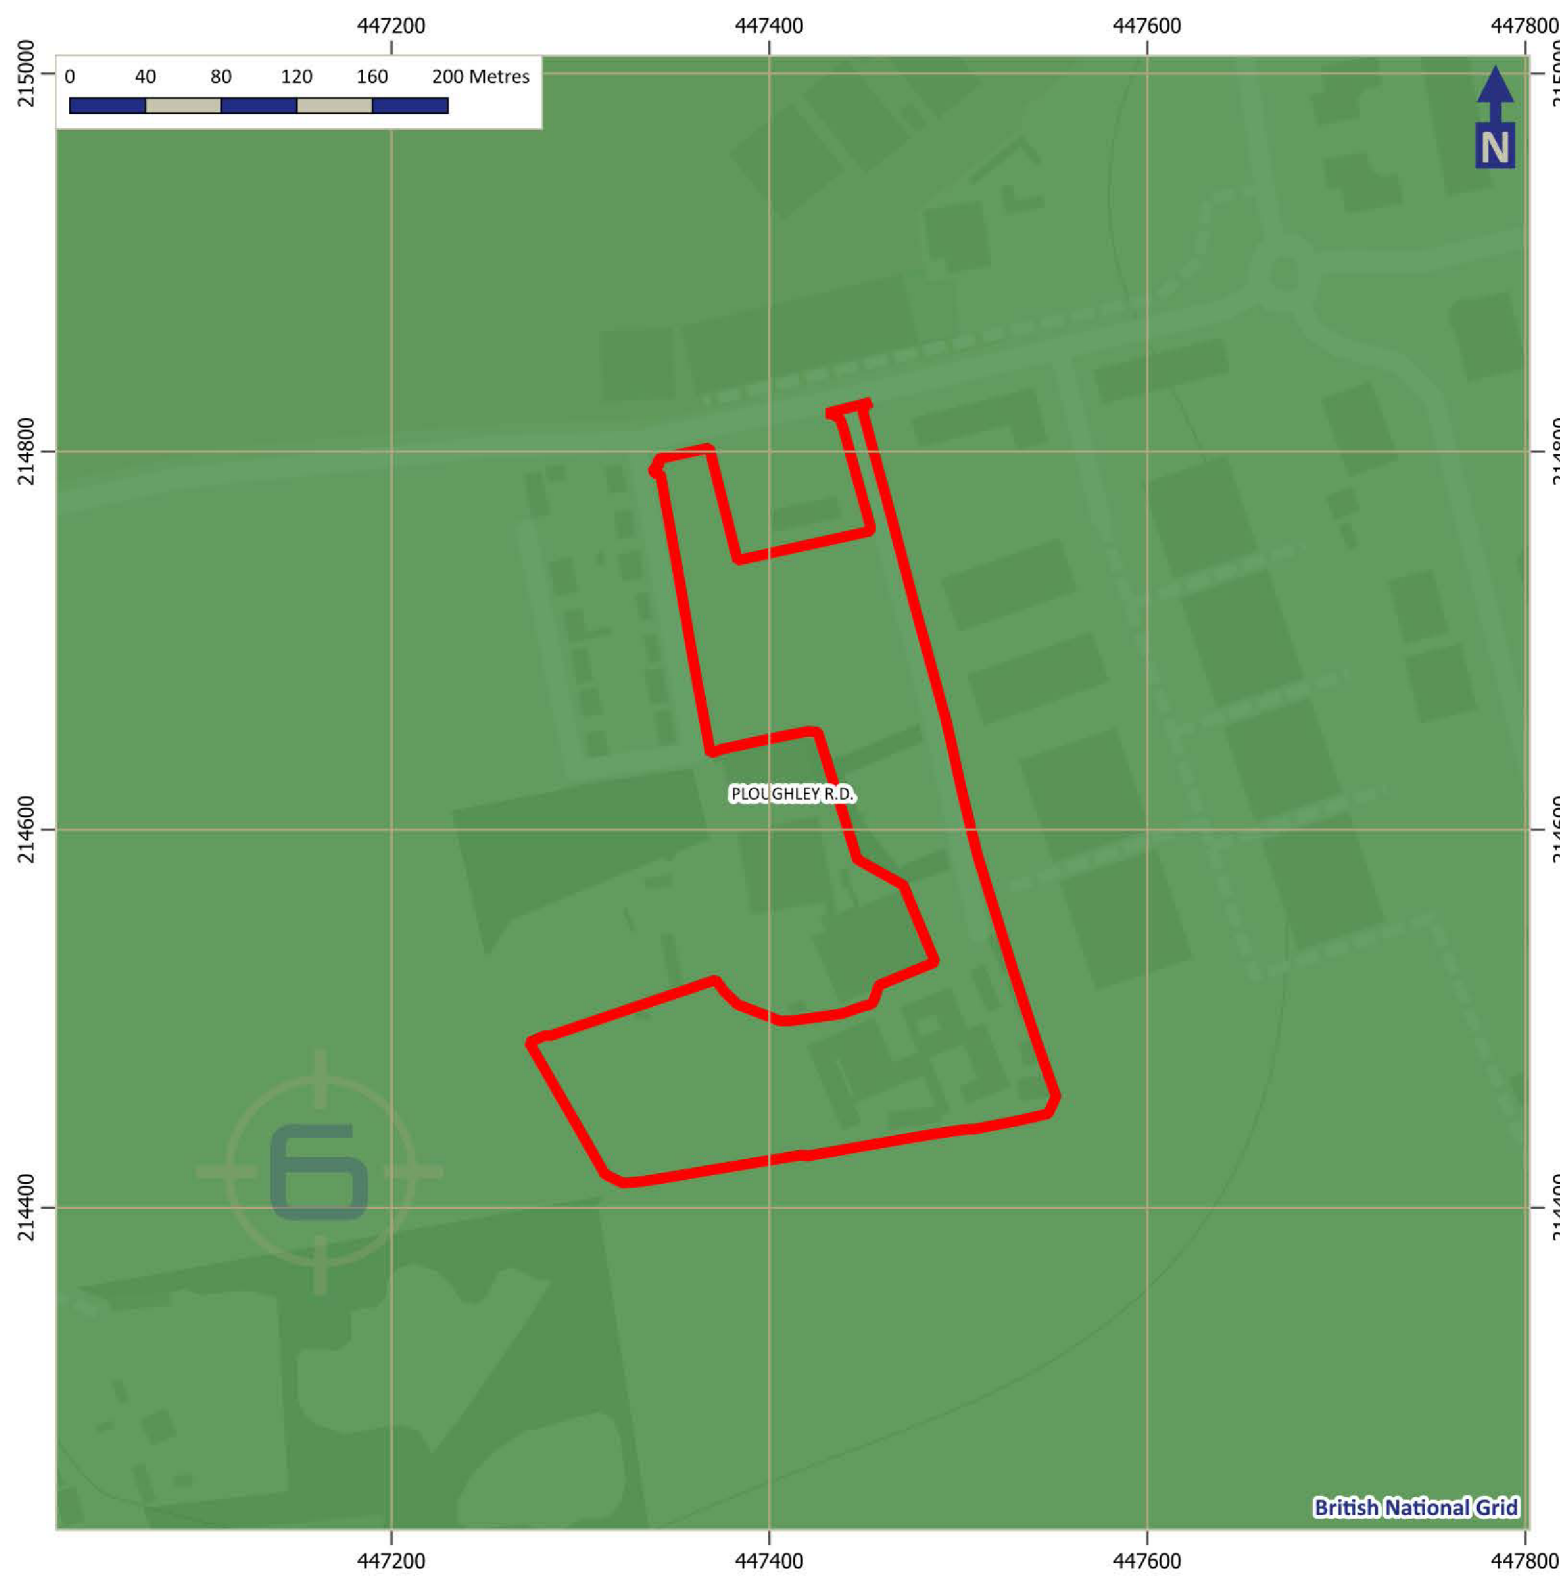
Appendix 5 – WWII High Explosive Bomb Density

WWII High Explosive Bomb Density

The Study Site was located within *Ploughley Rural District*, as presented at Appendix 5. This region recorded one HE bomb strike per 100 hectares, a “very low” level of bombing. However, further site-specific data has been considered regarding the potential bombing of the Site during WWII.

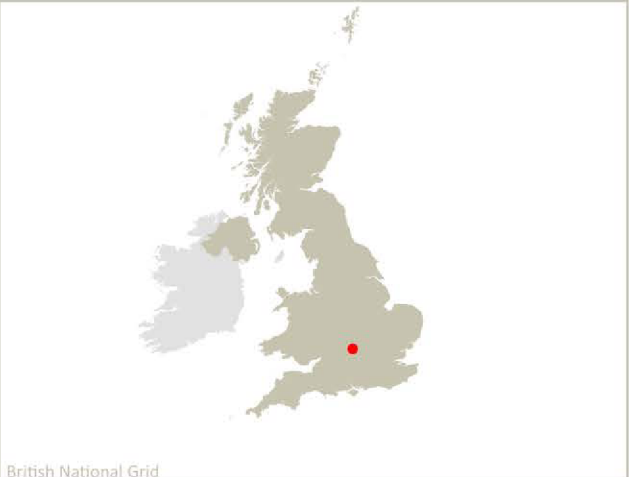
- Site Boundary
- High Explosive Bomb Density
 - Less than 15 bombs per 100 hectares
 - 16-25 bombs per 100 hectares
 - 26-35 bombs per 100 hectares
 - 36-45 bombs per 100 hectares
 - Over 46 bombs per 100 hectares

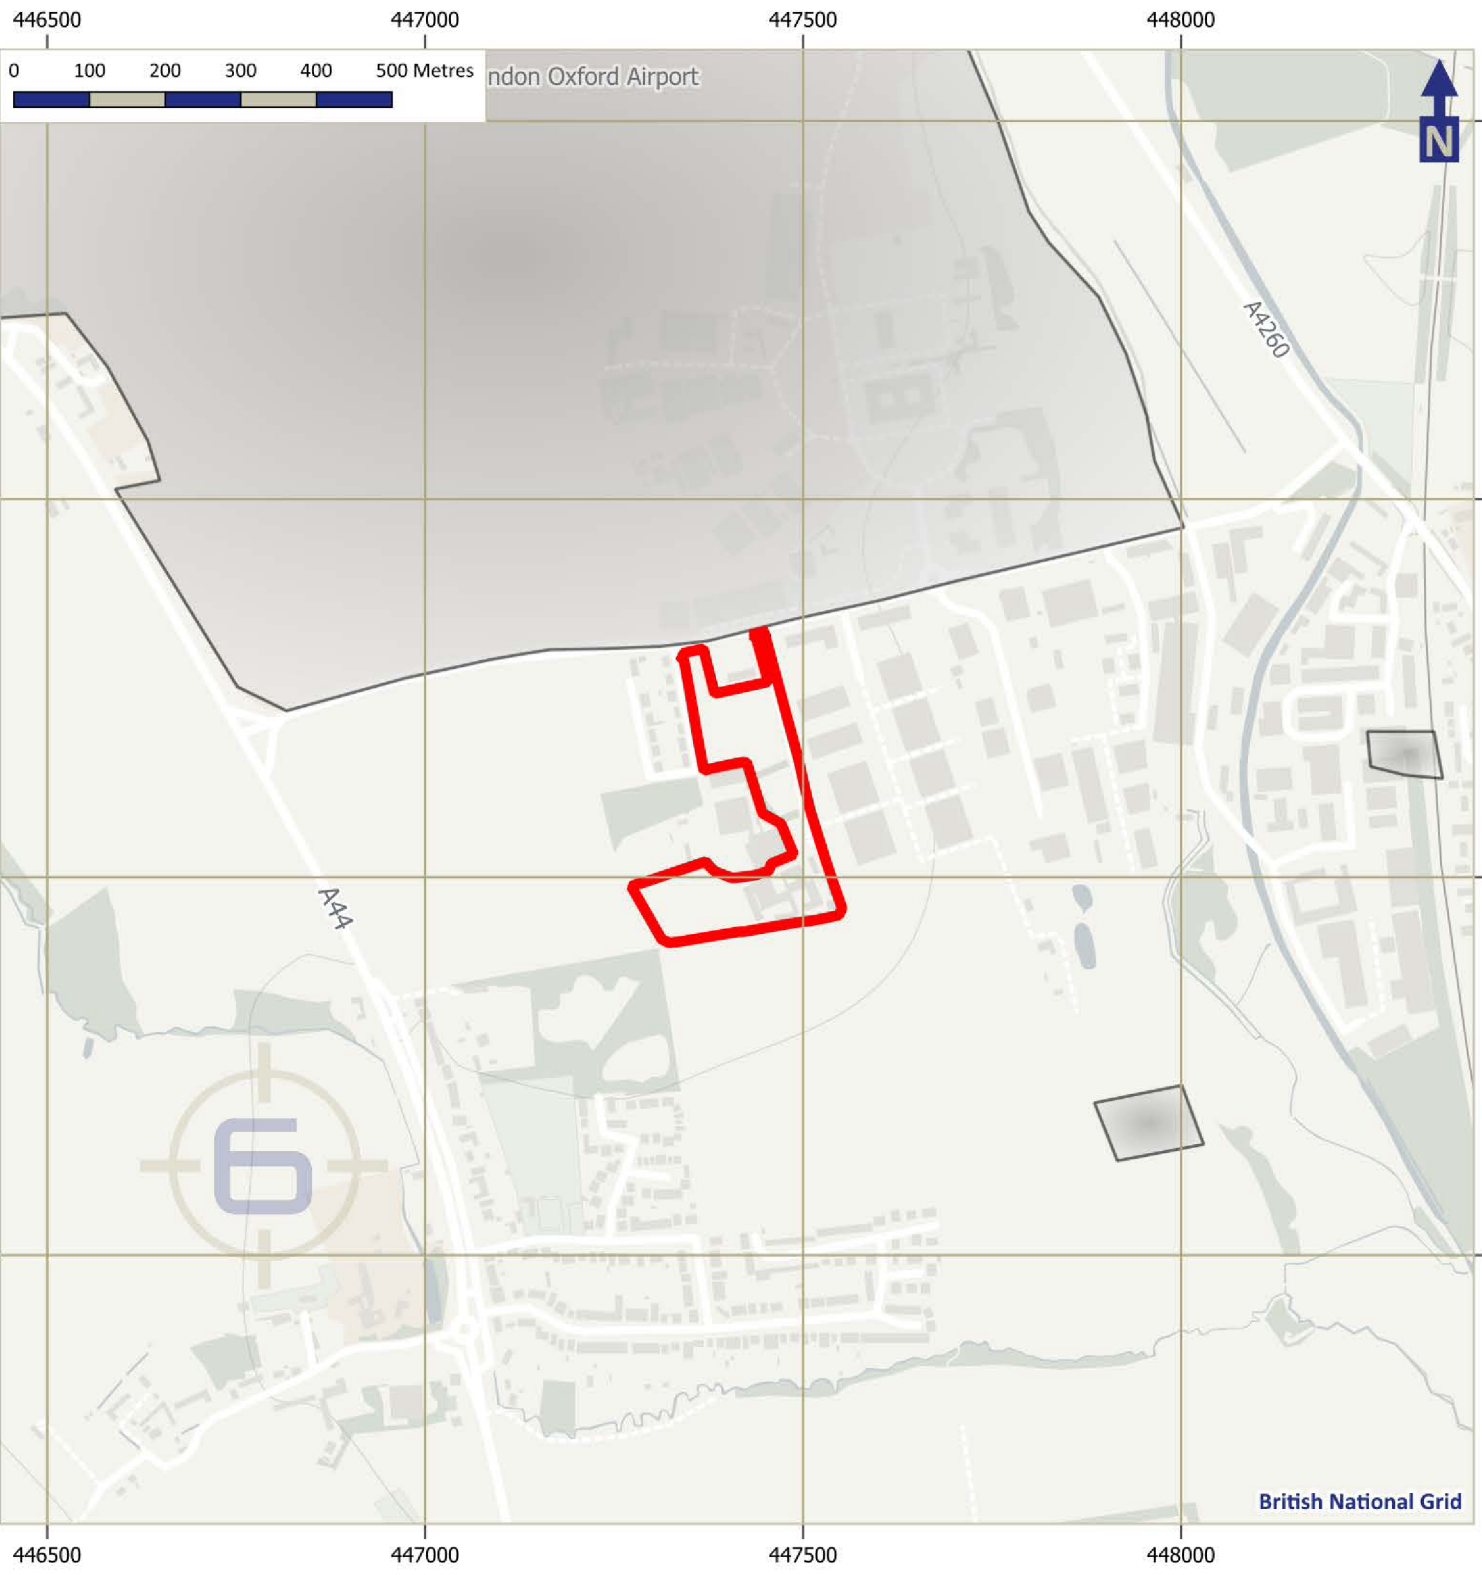
Appendix 7 – Historic Military Activity

Historical Military Activity

The Study Site itself was located outside of the main airfield site, although it was linked to the airfield via a track to allow for aircraft testing. *Air Training Oxford Ltd*, originally based on the main site, was relocated to *Campsfield House* (located on-site), which was utilised as a repair and maintenance facility for various aircraft including *Hawker Hurricanes* and *North American P-51 Mustangs*
