Appendix D – Lighting – Supporting images

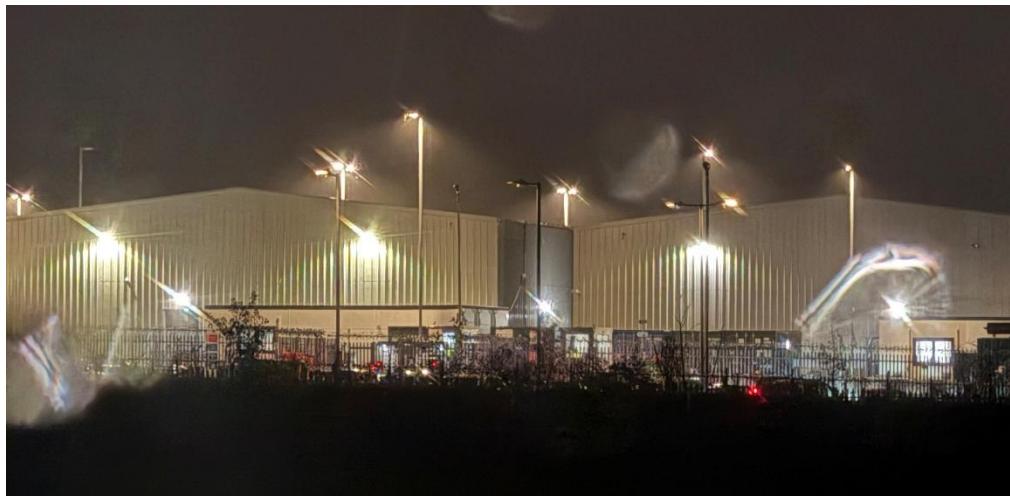
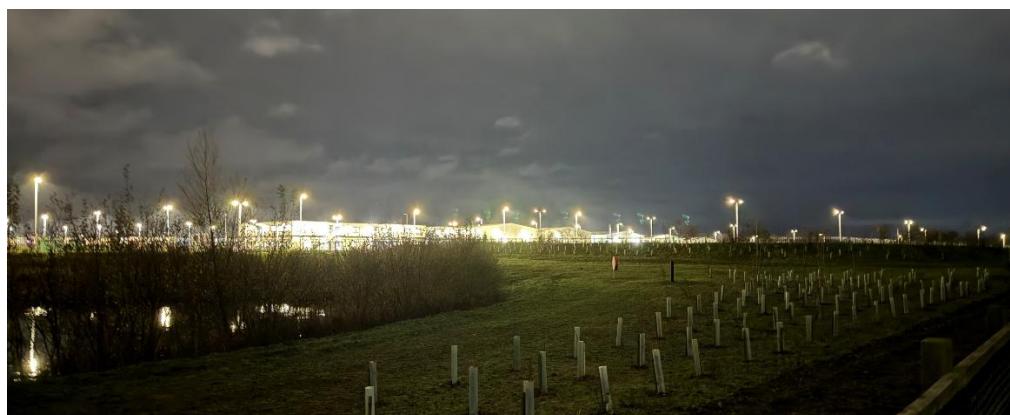
The following images show glare and reflectance from building attached lighting, reported as turned off within the lighting impact assessment (Image November 2025).

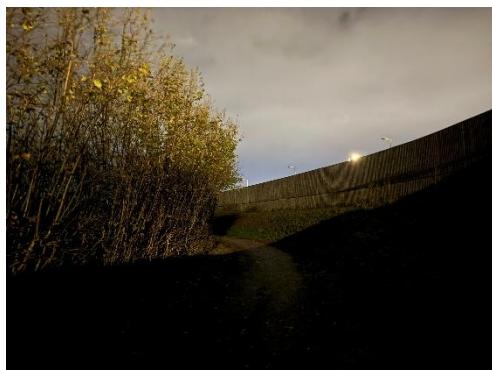
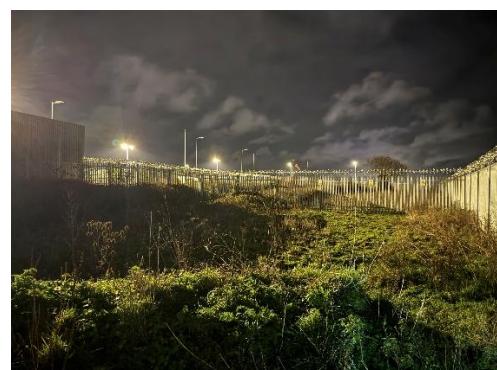
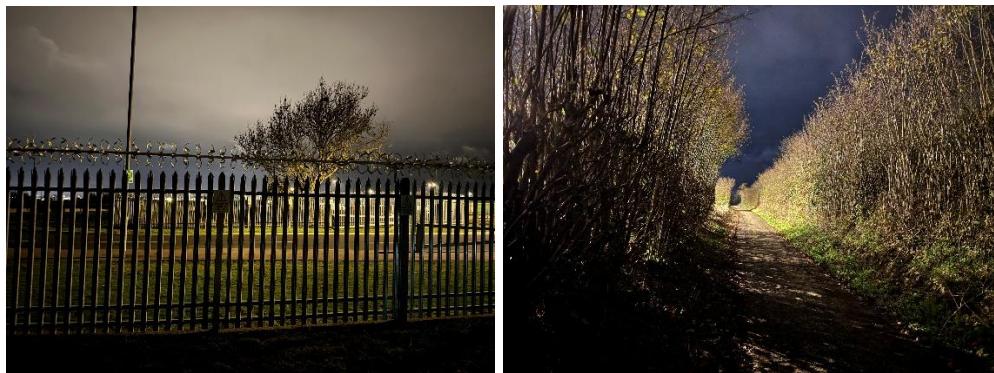
The following are recent images following fitting of baffles, local dimming and switching off of lighting. Light continues to spread to biodiversity retained areas.

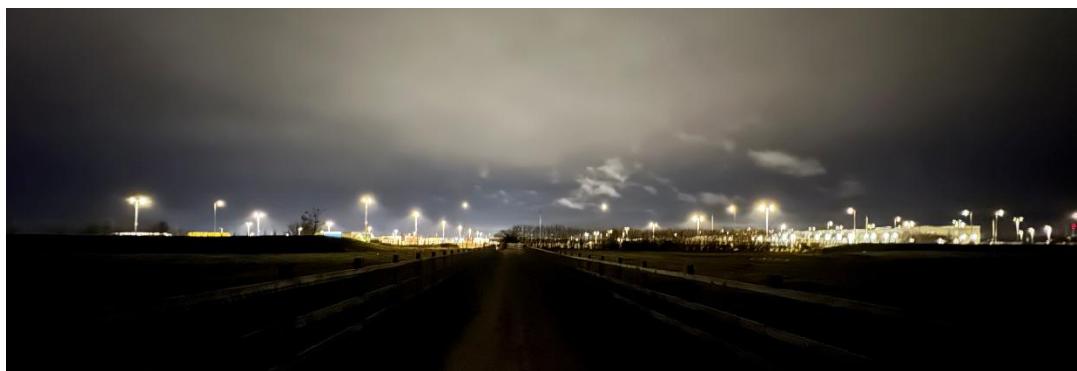
View of the site from AE639 from Mersham

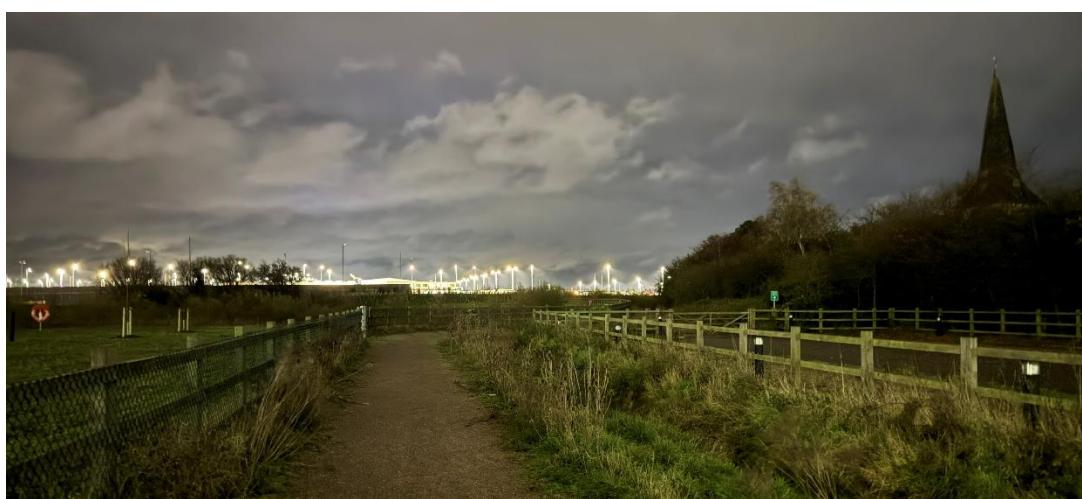
View of the site from bridleway adjacent to St Mary's Church

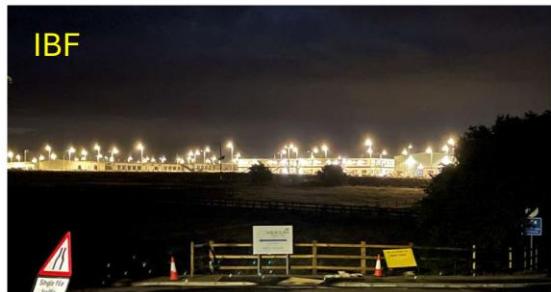
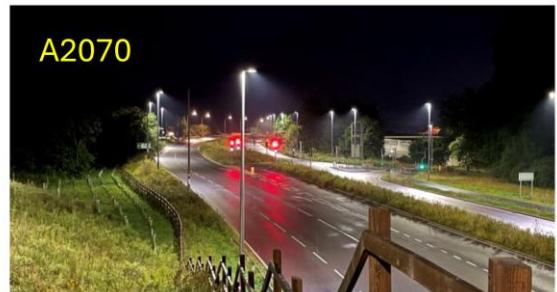
Previous images as submitted showing difference in luminaire design and glare

Comparison with new A2070 street lighting which has significantly better light pollution performance
