11 Appendices

Project Description / Site
IRC Campsfield House
Phase 1 Refurbishment

Client Project
Home Office Campsfield IRC
Phase 2 Expansion

IRC Campsfield House – Infiltration Testing

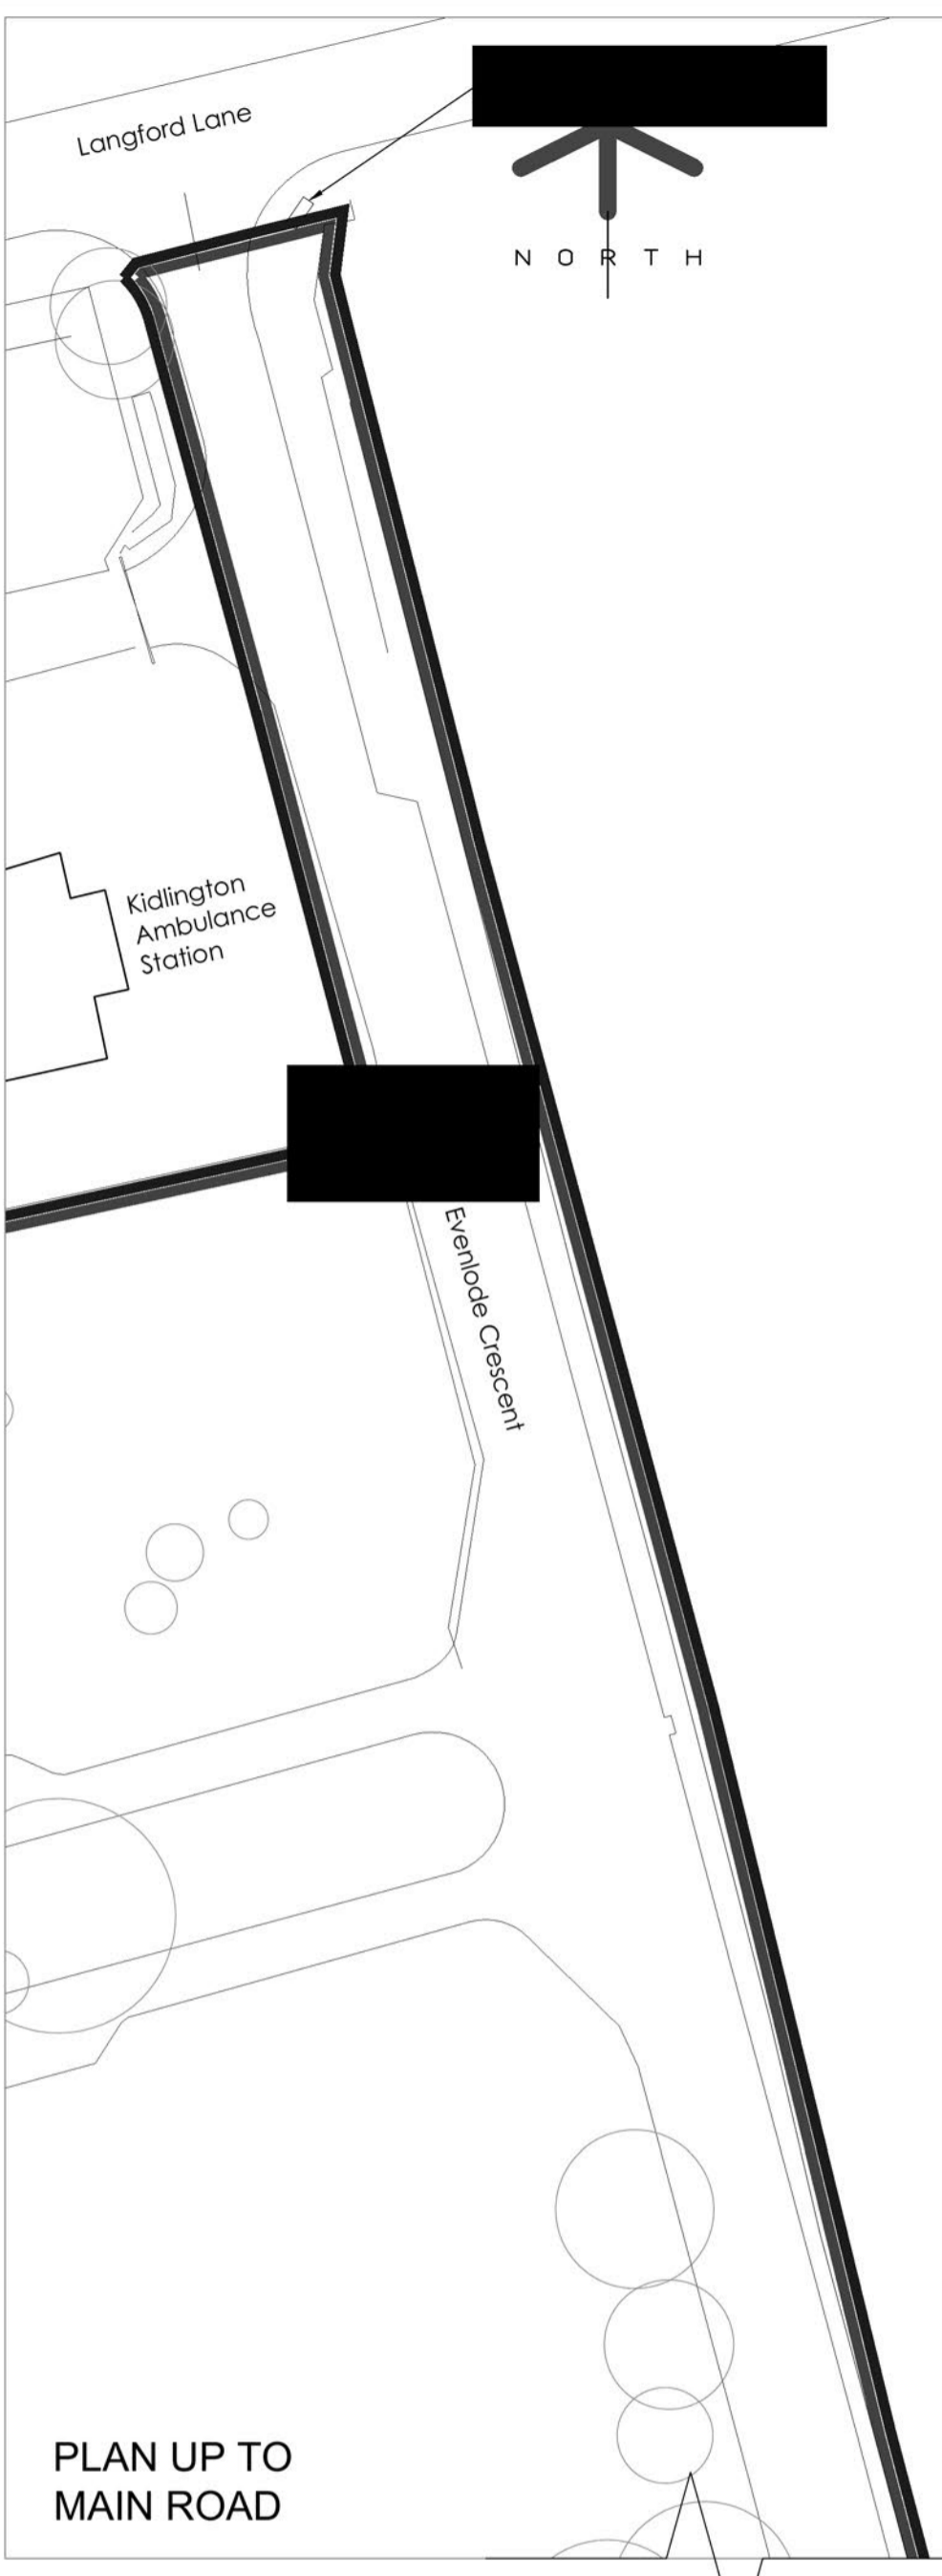
Drawing Title
Proposed Site Plan Phase 1

Road continues in drawing extract on right

PLAN UP TO MAIN ROAD

Road continues from main site plan

- Notes**
- Denotes extent of Ministry of Justice Ownership
 - IRC Campsfield - Phase 1

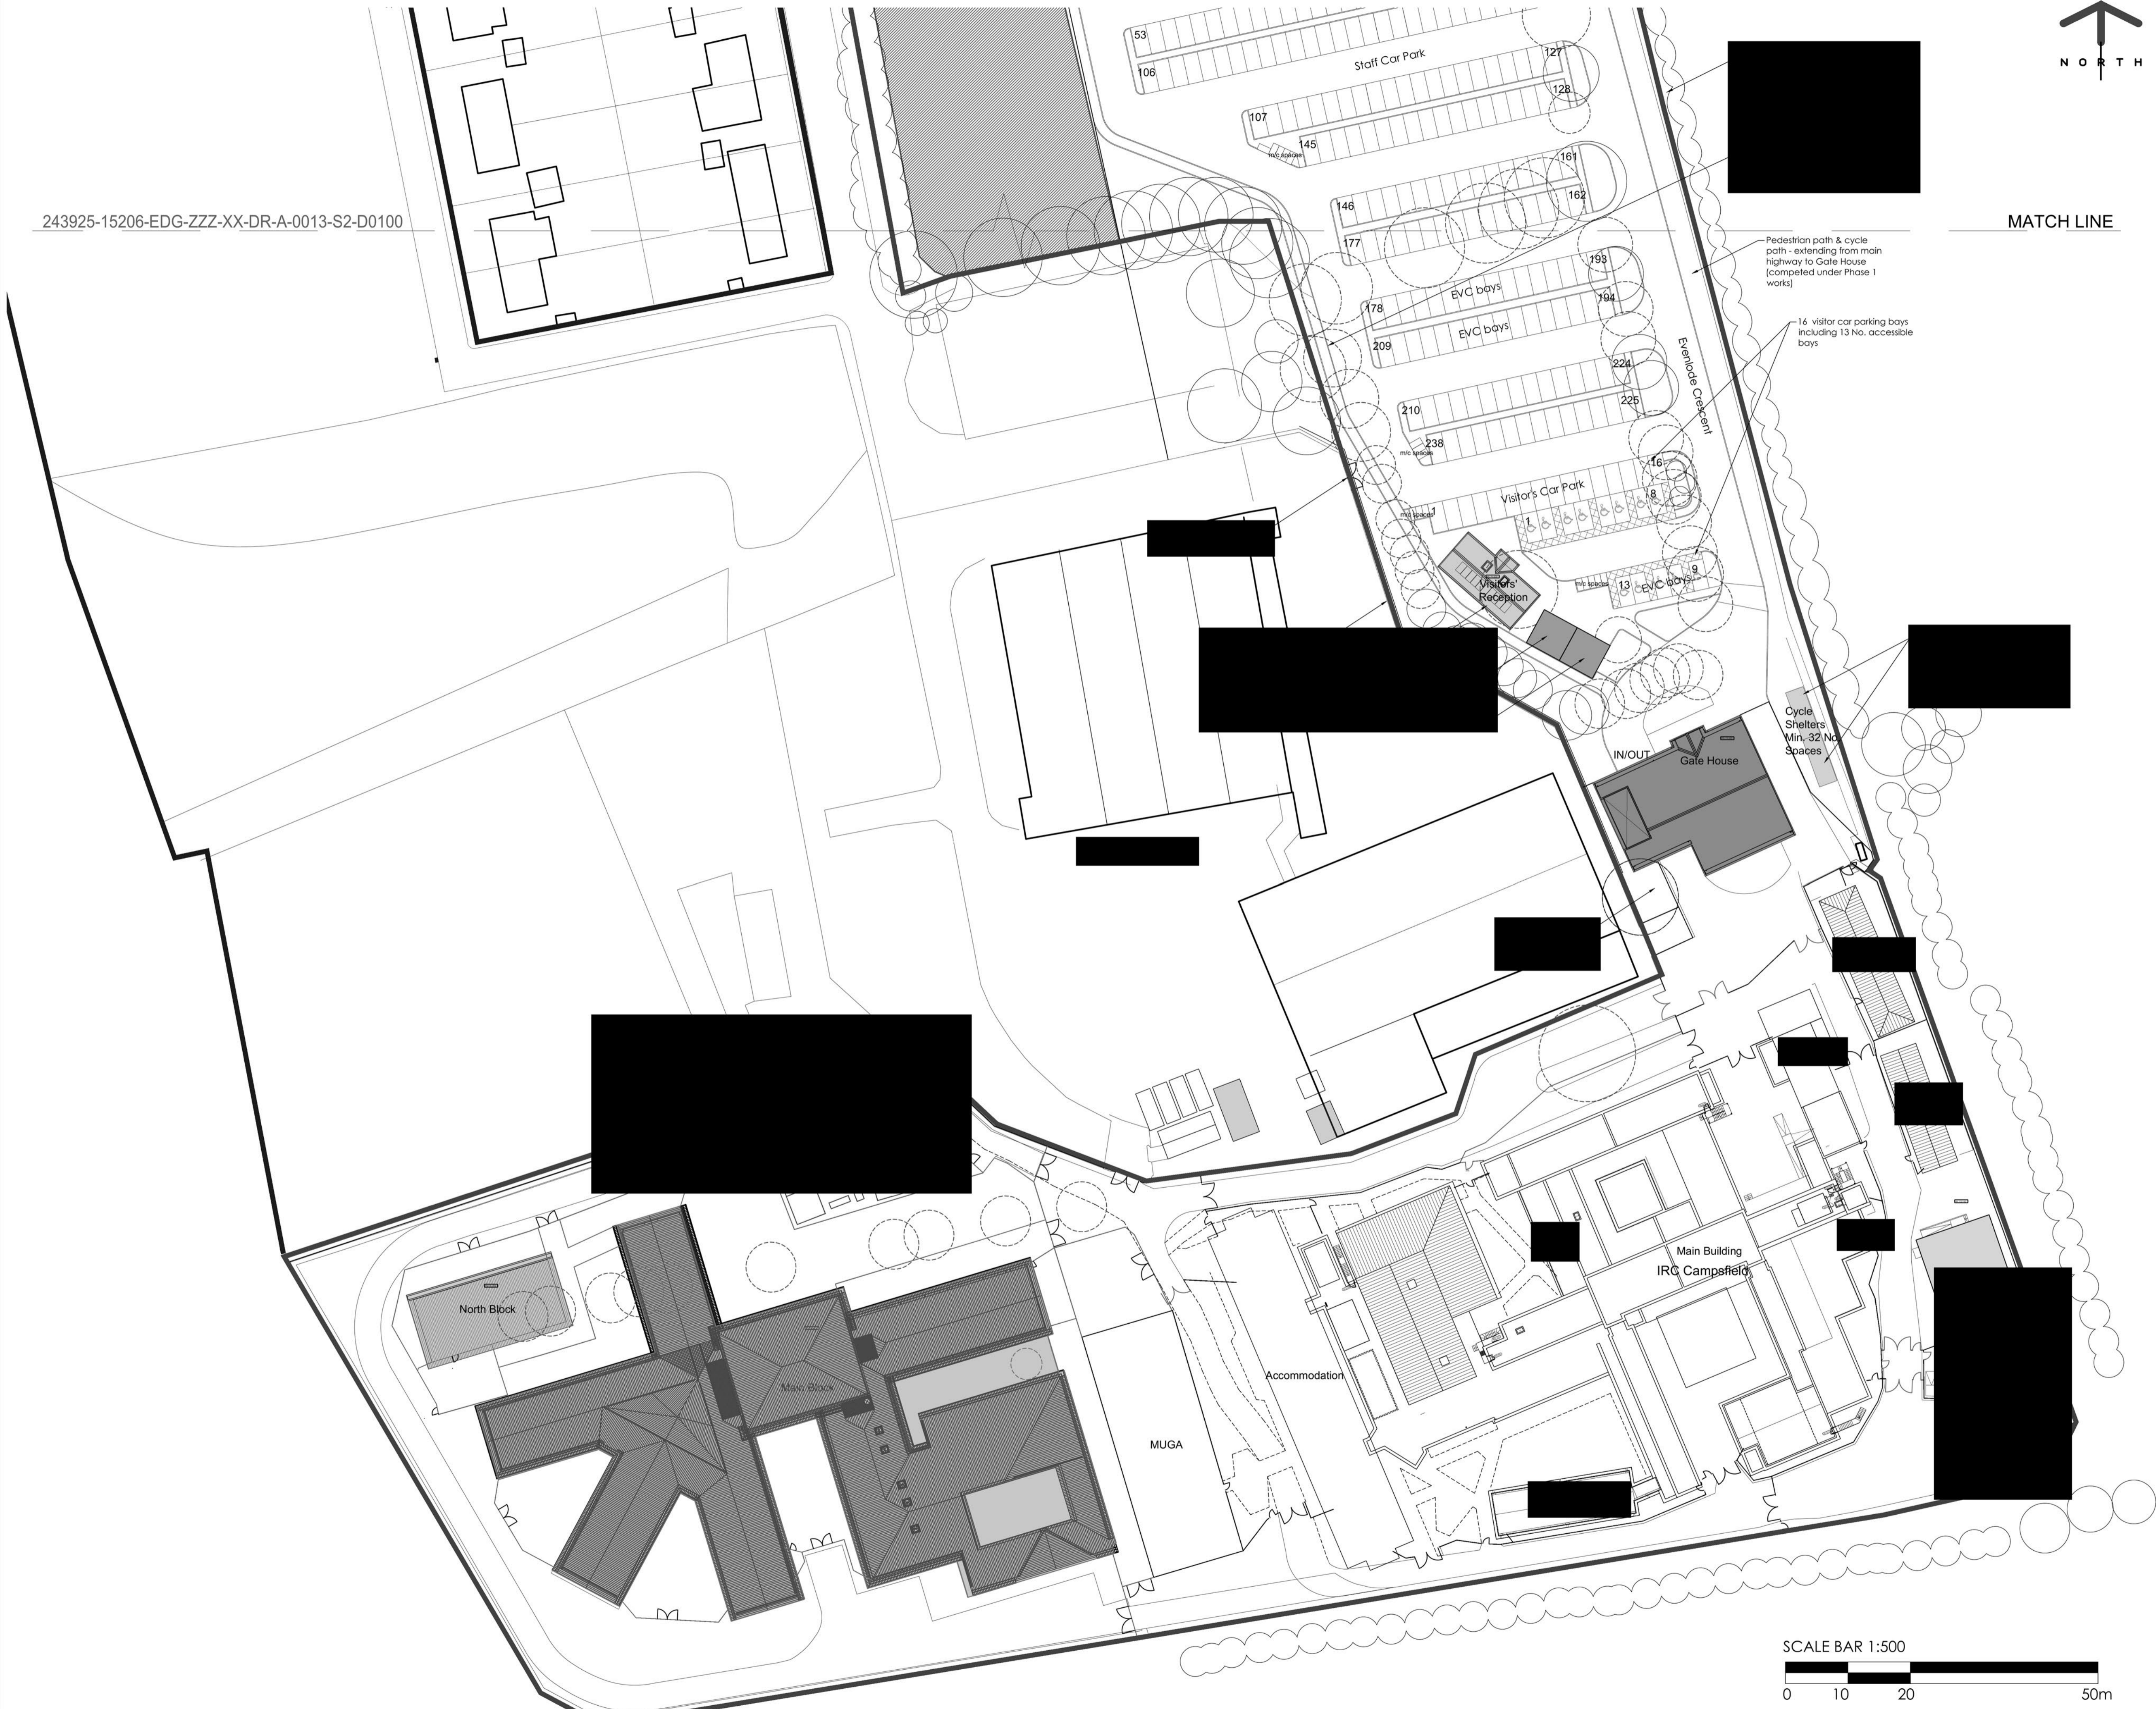
243925-15206-EDG-ZZZ-XX-DR-A-0013-S2-D0100

- Notes**
- Denotes extent of Ministry of Justice Ownership
 - Denotes area of IRC Campsfield

- Trees to be removed

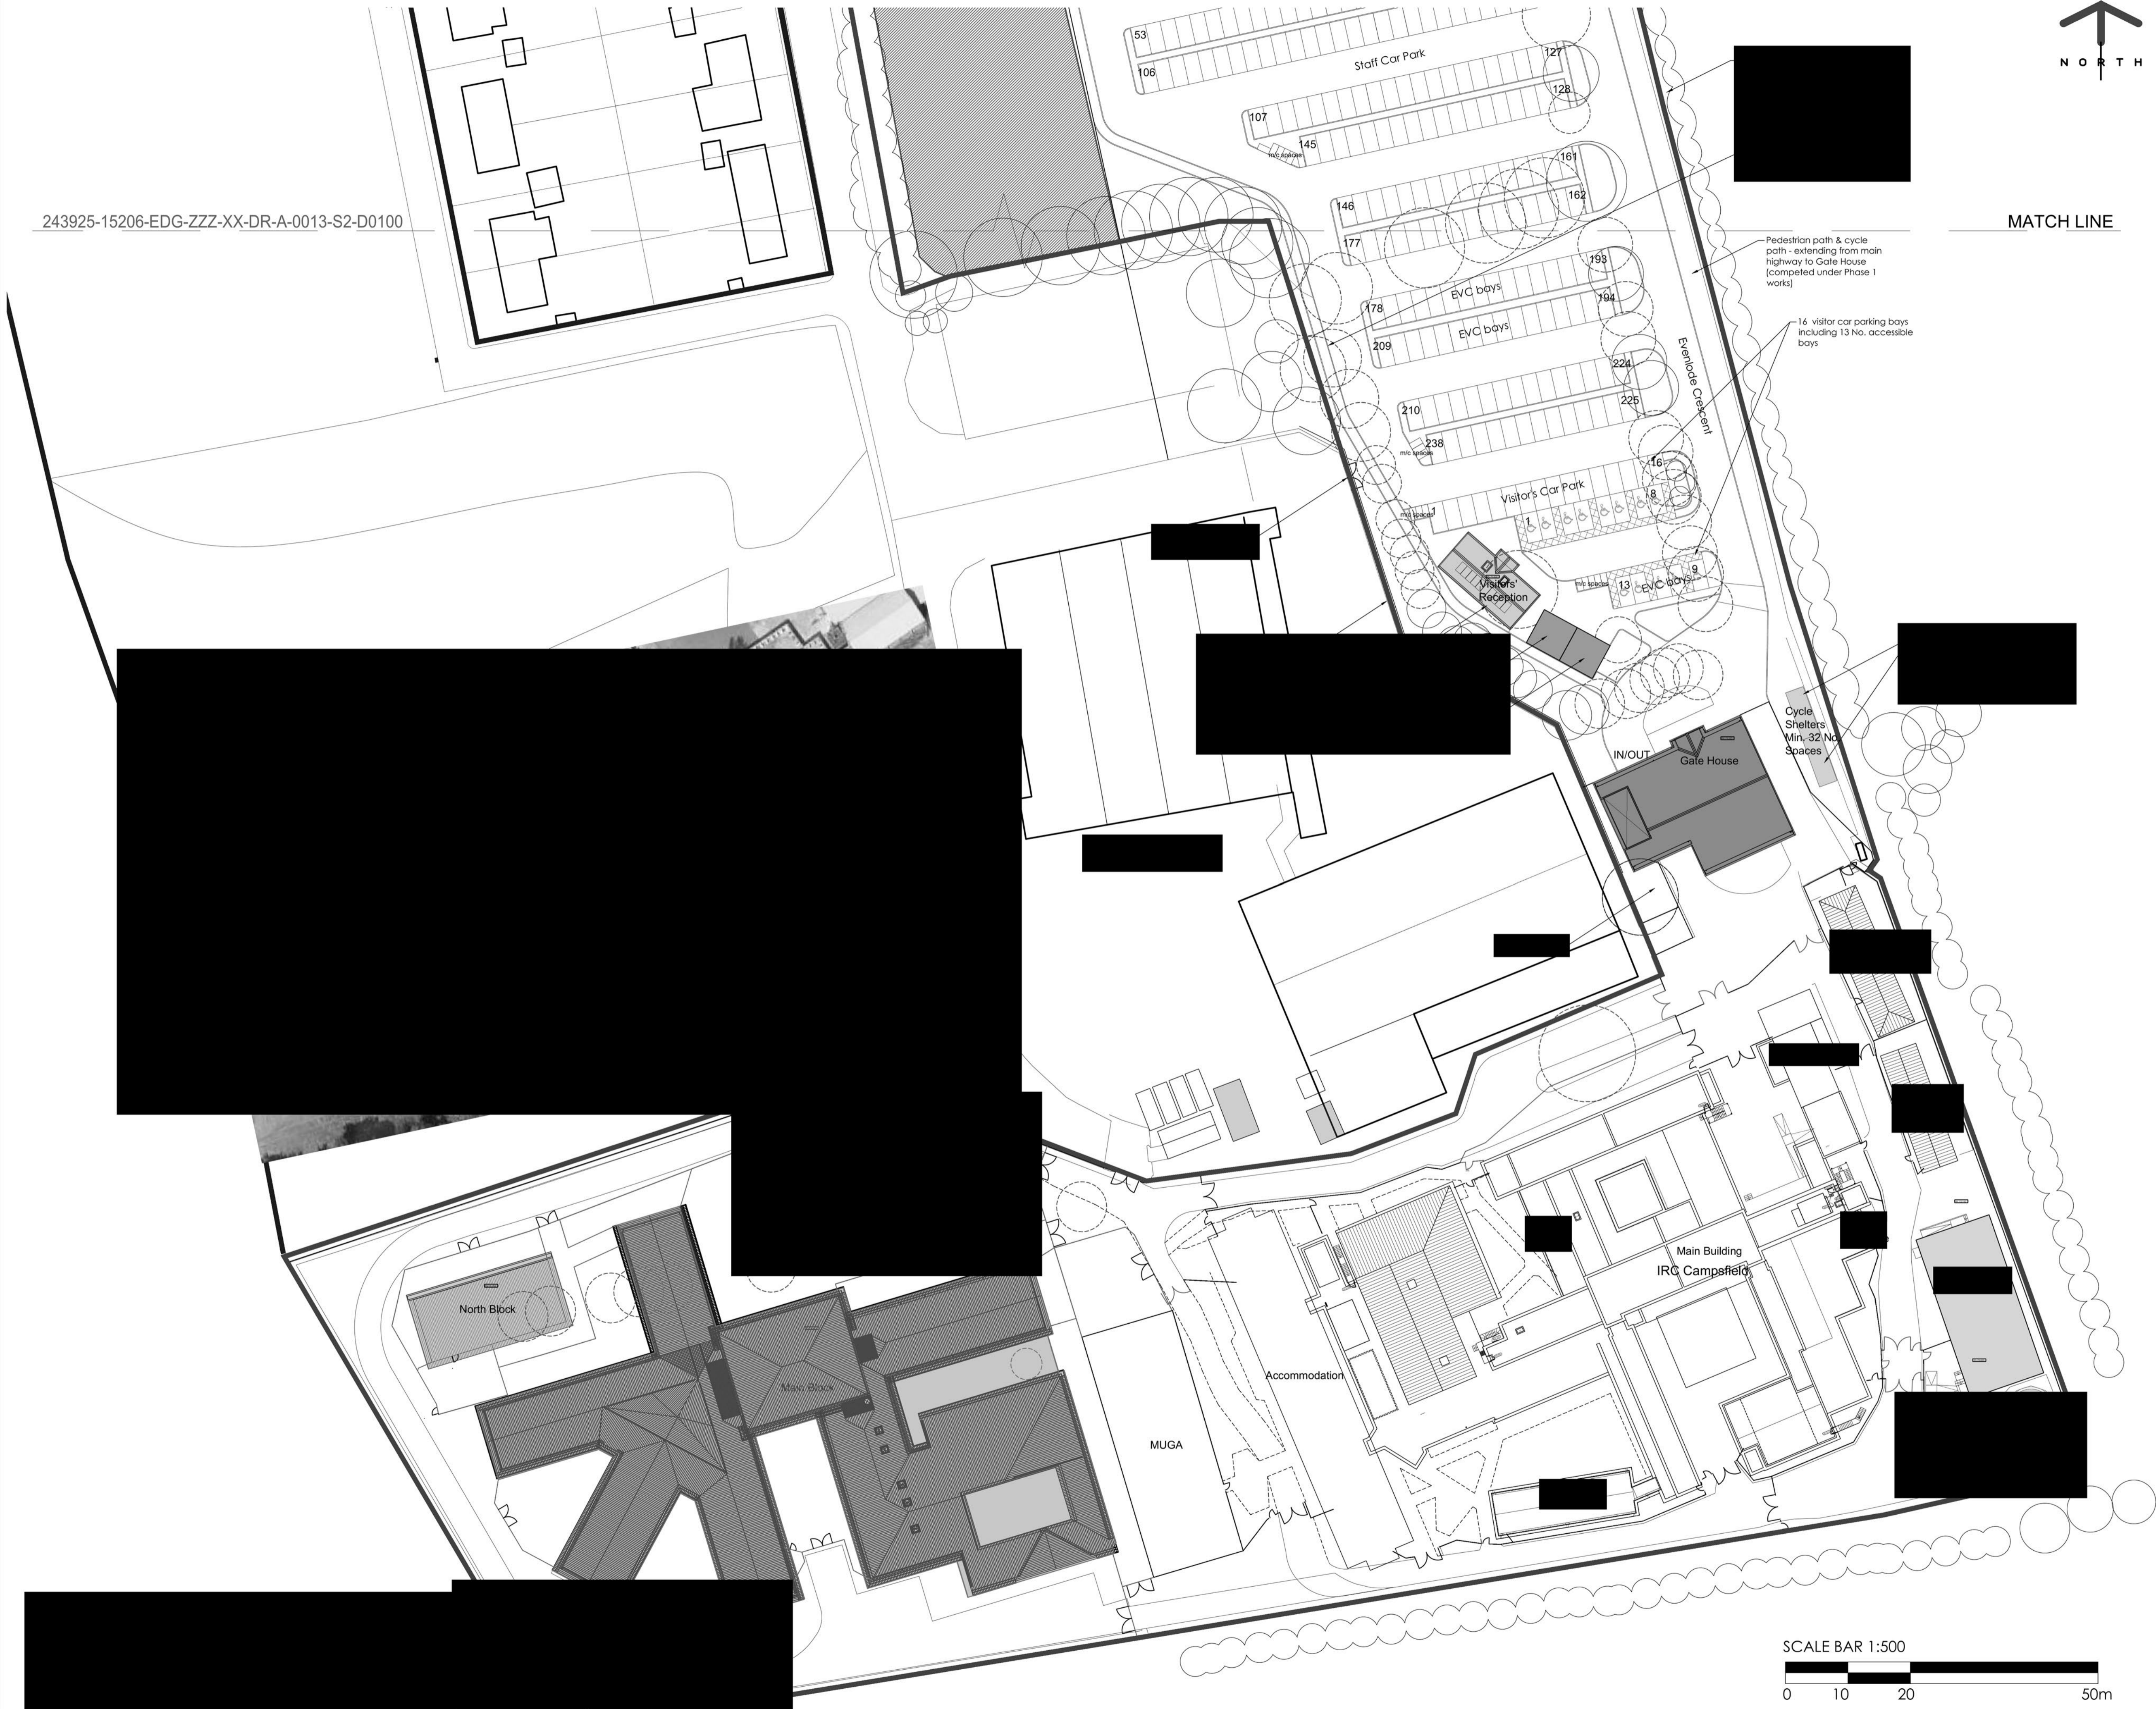
- Notes**
- Denotes extent of Ministry of Justice Ownership
 - Denotes area of IRC Campsfield
 - New External Plant
 - Trees to be removed
